### Heritage Impact Assessment

Land off Rhos Street, Ruthin, Denbighshire

On Behalf Of: Medra (Tia) Cyfyngedig

December 2021

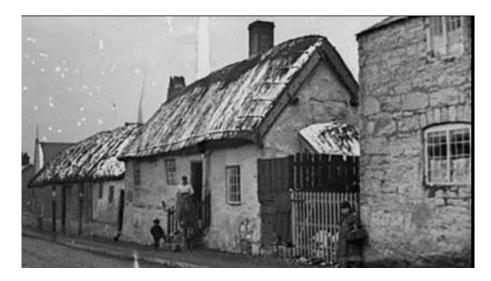
**Figure 4.1:** Rose Cottage and the adjoining single-storey cottages that were cleared to make way for the junction into Haulfryn c.1870 (https://facebook.com/ruthun/photos)

- 4.15 The single-storey thatched cottages that extended from the western gable of Rose Cottage, and may have been broadly contemporary (Figure 4.1), were removed during the mid C20th and replaced with the junction that leads into Haulfryn. The rear of the property, in views from Haulfryn is partly concealed by the modern rear extension.

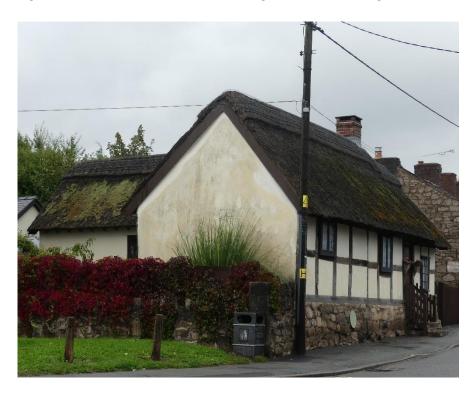
Figure 4.3: The front elevation and west gable of Rose Cottage

4.10 The west gable appears to have been re-rendered, concealing the cruck frame since the list entry was last amended in July 2006. However, the timber-frame structure remains legible to the eastern gable. The stepped ridge, that drops slightly to the later, right-hand, bay remains evident within the renewed thatch, allowing the phasing of the building to be appreciated. The fact that it has survived as a 'workers cottage', which would have been a comparatively low status building in the context of the grander timber-framed buildings in the historic core of Ruthin, is an important part of the historic value of the building.

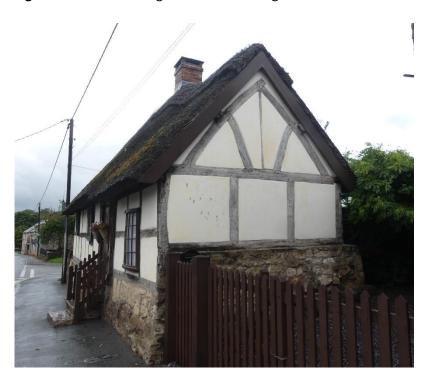
Figure 4.4: The eastern gable of Rose Cottage

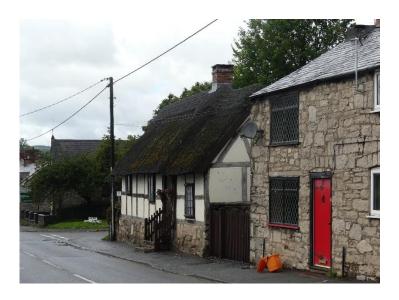
**Figure 4.5:** The view westwards towards Rose Cottage in comparison to the late C19th view (Figure 4.1)

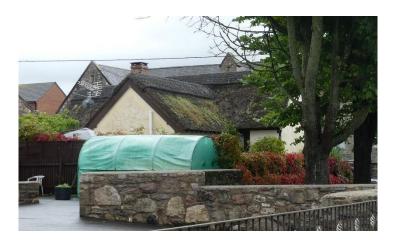
Figure 4.6: The rear of Rose Cottage from Haulfryn

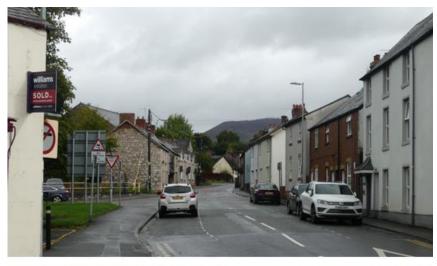
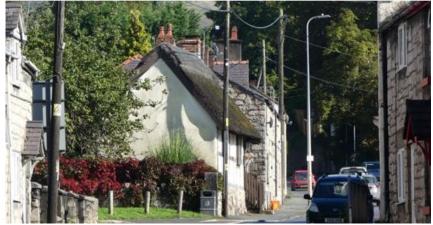
**Figure 4.7:** Rose Cottage helps terminate views eastwards along the original curved alignment of Rhos Street and is appreciated through a sequence of kinetic views that allow the timber-framed and thatched cottage to be seen against the contrasting stone terrace

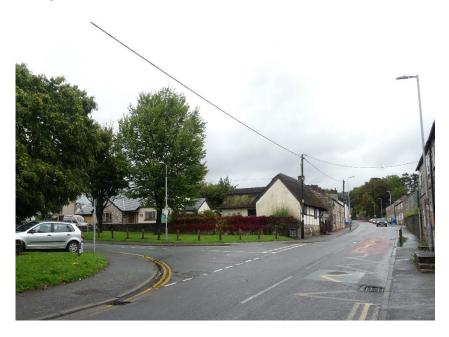
**Figure 4.8:** The open junction of Haulfryn to the west of Rose Cottage

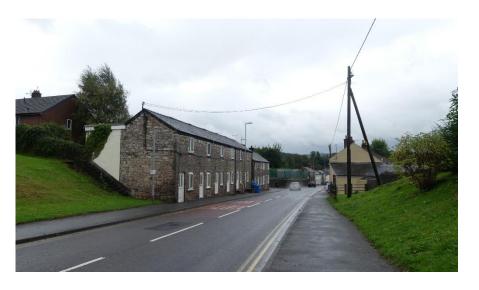
Figure 4.9: The view westwards along Rhos Street

- 4.16 Rhos Street School was set back behind the original playground to contrast with the enclosure of the adjoining residential properties. In views eastwards and westwards along Rhos Street, the school is largely obscured and does not contribute to the ability to appreciate the listed building, this experience is also accentuated by the slight curve in the street alignment.
- 4.17 The open aspect across the playground does allow Rose Cottage to be appreciated, albeit through the modern fencing that encloses the playground.

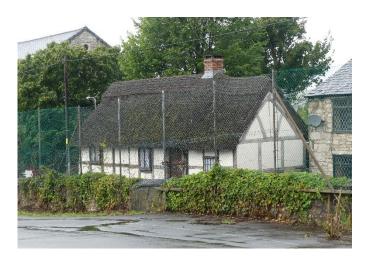
**Figure 4.10:** Rose Cottage viewed from Rhos Street School playground

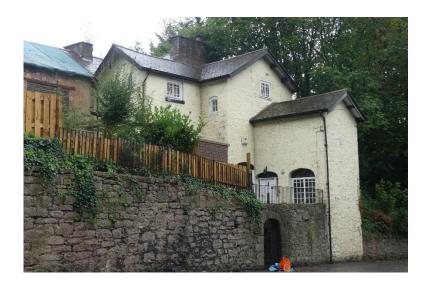
**Figure 4.11:** The two and three storey ranges that step back from Rhos Street behind the robust stone retaining wall

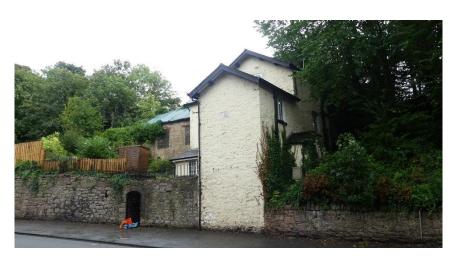
Figure 4.12: The largely blank roadside wing

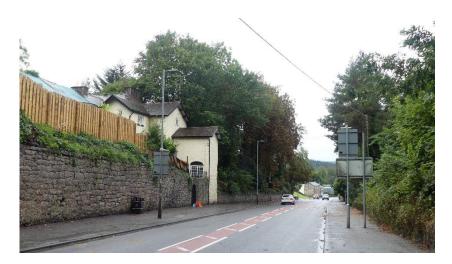
**Figure 4.13:** The view westwards along Rhos Street from Stansty Cottage

- 4.22 Stantsy Cottage has managed to retain a sense of its isolated position on the eastern edge of the town. This is partly a function of the distinctive relationship with the steep embankment and the mature tree cover. The immediate surroundings of the topography of the plot, the adjoining agricultural buildings and secure boundary to Rhos Street are all aspects of setting that make a positive contribution to the significance of the listed building.
- 4.23 The application site is located approximately 175 metres to the west of Stansty Cottage. The school building is obscured by intervening tree cover and buildings, with only the front boundary of the site visible from the listed building.

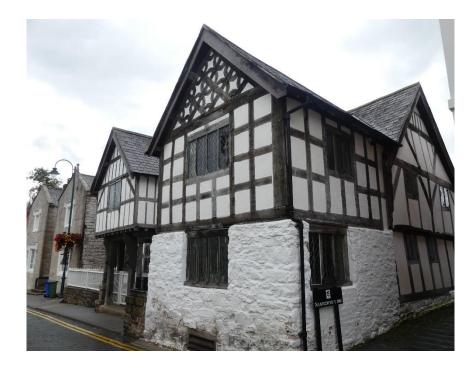
Figure 4.17: Nantclwyd House, Castle Street

of Ruthin. In addition to the Castle and St. Peter's Church, notable buildings include Nantclwyd House, which dates from the C15th, with possibly earlier fabric, while numerous buildings provide evidence of timber-frame structures from the C17th

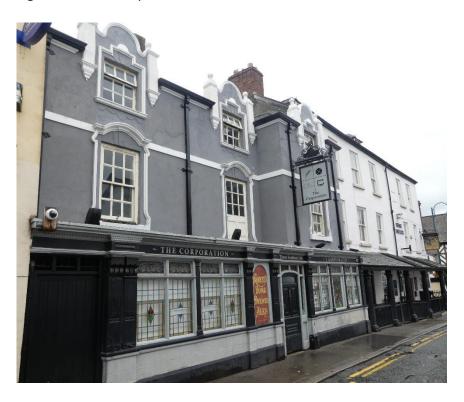
Figure 4.18: The Corporation Arms, Castle Street

4.32 Many of the buildings in the conservation area contain fabric of earlier buildings and have been adapted over time, for instance the list entry for the Corporation Arms on Castle Street refers to C17th fabric or earlier, while the frontage was rebuilt during the late C19th.

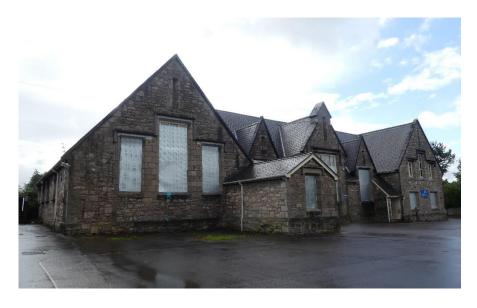
Figure 4.21: The front elevation of Ruthin British School

4.40 The front elevation of the school has remained largely intact, with the exception of the single-storey porch, which was added between 1875 and 1900, and the upper parts of several of the taller windows, which have been blocked internally to accommodate internal subdivisions. All of the window frames have been renewed.

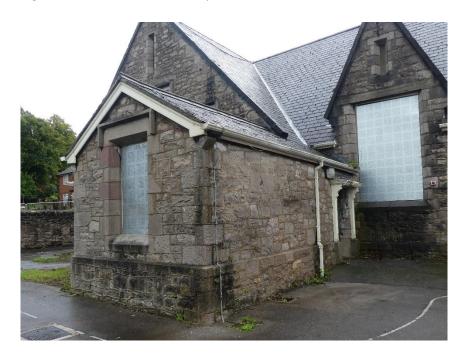
Figure 4.22: Detail of the front porch

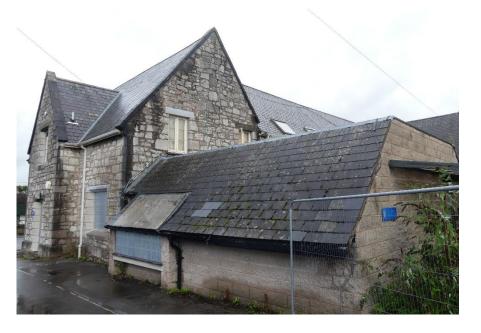
Figure 4.23: The western elevation and associated extension

4.41 The western elevation of the school is similarly intact, with the exception of the window frames and replacement stonework to several sills and arches. However, substantial extensions have been

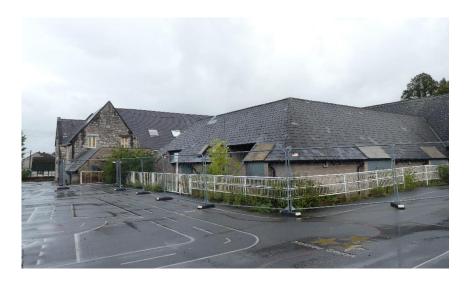
Figure 4.24: The south-western corner of the rear extension

- 4.42 The main rear extension had been constructed by 1984, while the extension to the rear of the western wing was constructed between 1984-94.
- 4.43 The extensions are single-storey, and are constructed from concrete blockwork under a variety of slate clad roof forms, which overstate the proportions of the roof due to the depth of the building. However, externally, the phases of the building are clearly legible.

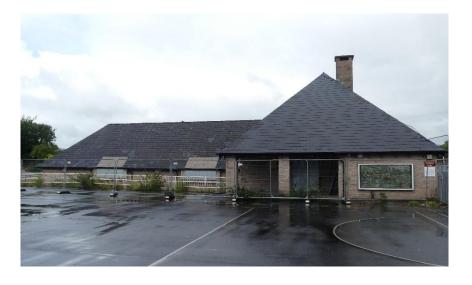
Figure 4.25: The southern elevation of the rear extension

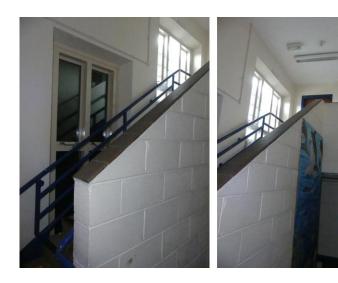
Figure 4.28: The eastern staircase

4.45 The modern staircases are constructed with painted concrete blocks and cut across the taller panels of windows to the front elevation. The western staircase is constructed around a central column of blockwork, while the space containing the eastern staircase is narrower and it simply comprises two flights and a half-landing. An attic floor has been inserted, the queen post trusses remain exposed, while the upper part of the taller window to the central range is enclosed within the roofspace.

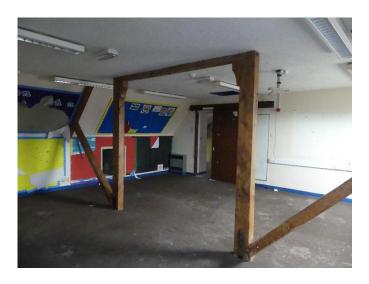
**Figure 4.29:** The first-floor space within the roof

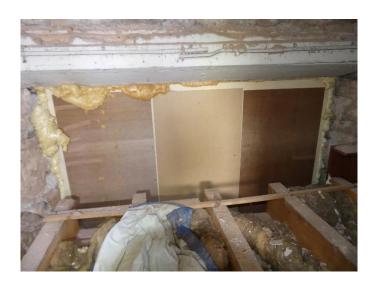
**Figure 4.30:** A window head concealed within the roofspace

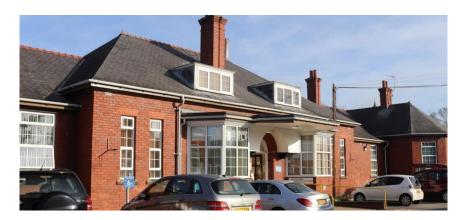
Figure 4.31: The western elevation of Ruthin Community Hospital

4.48 The original hospital building adopted a linear, broadly north-south, form, with a symmetrical plan centred on a principal western elevation that is framed with outer pavilion bays. The hospital is

- constructed from red brick, in a stretcher bond, under a slate roof with corbelled axial stacks. The windows have been replaced, however the openings retain their gauged brick heads and stone sills.
- 4.49 The hospital formed part of a cluster of public buildings, including the former British School, which functioned in association with the adjoining Union Workhouse.
- 4.50 A linear extension was added in parallel to the rear of the hospital during the 1970s-80s.
- 4.51 The heritage value of the hospital is principally derived from its association with the Union Workhouse and the restrained architecture of the symmetrical plan form of the original hospital building.
