## **ADRA**

Development at the Former Rhos Street School , Rhos Street, Ruthin

PHASE I GEO-ENVIRONMENTAL DESK STUDY REPORT

**Document Reference:** 4863-CAU-XX-XX-RP-O-0300

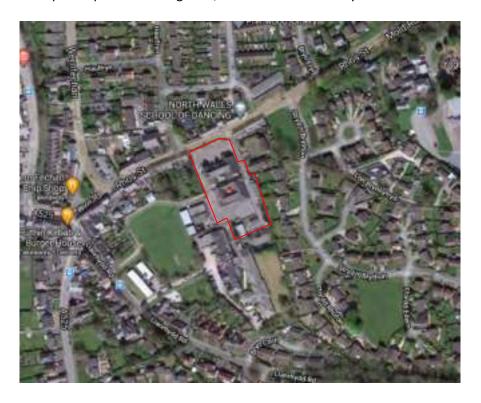
Figure 1: Location plan of site with red line boundary

- 2.1.1 The Site is located approximately 300m southeast of Ruthin town centre, at National Grid Reference of 312867, 358208 .
- 2.1.2 A Site location plan is provided as Figure 1, with red line boundary around the site area.

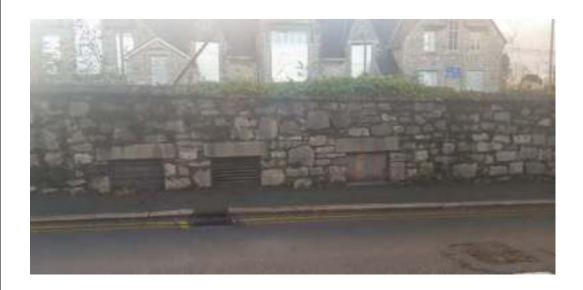
Possible historical basement feature within retaining wall along northern boundary (Rhos Street).

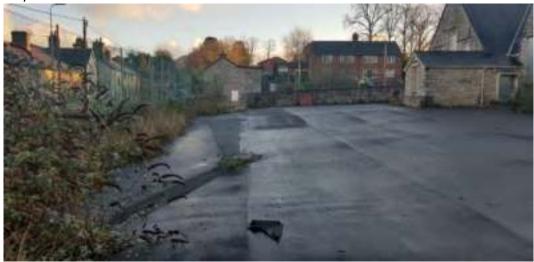
Playground above Rhos Street Retaining wall, no evidence of infilled basement, although playground has been resurfaced.

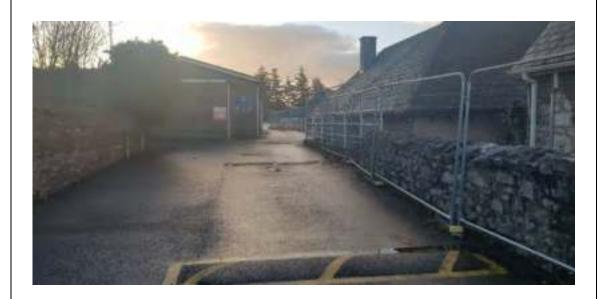
3

Current vehicular access off Rhos Street along eastern boundary of the site, with main school building approximately 1m below road level.

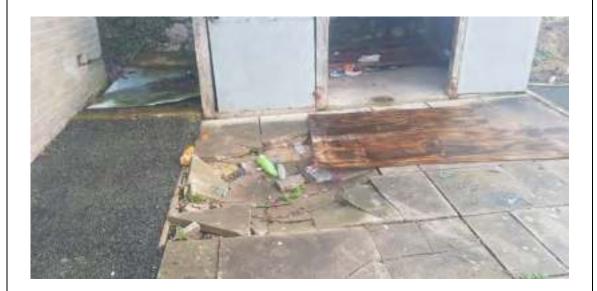
7

Collapsed paving in the east of the site to the north of the community building.

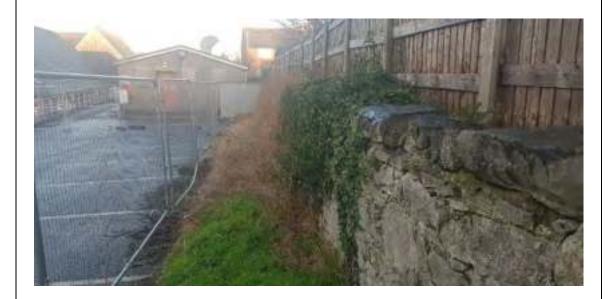
9

Stone retaining wall along eastern boundary, looking north.

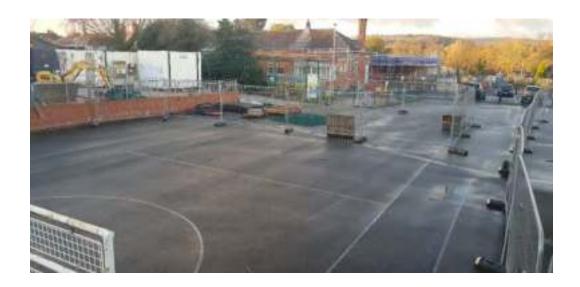
10

Playground to the south of the school buildings, part of which is currently being used as construction yard/site compound for adjacent hospital refurbishment work.

Brick retaining wall in the background supporting former school car park.

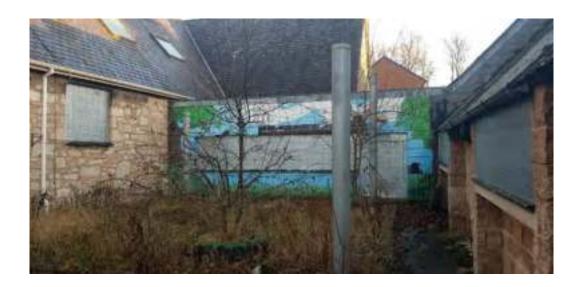
**12**

Courtyard area between the original school building to the left and newer extension to the right. Steel posts supporting former sun canopy.

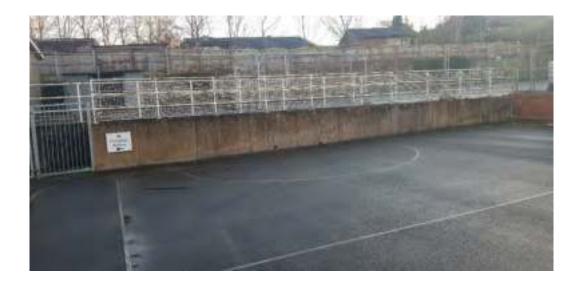
14

Concrete retaining wall in the east of the site supporting access road to car park located to the south of the playground.

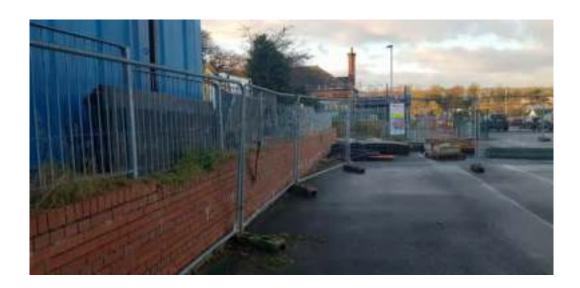
Brick retaining wall supporting car park above playground.
