**FOREMER RHOS STREET SCHOOL,  
RHOS STREET, RUTHIN  
LL15 1DY  
PHASE II GEO-ENVIRONMENTAL REPORT**

**Doc ref:** 4863-CAU-XX-XX-RP-V-3001

**Client:** Adra  
**Site:** Former Rhos Street School, Ruthin  
**Project Title:** Phase II Geo-Environmental Report  
**Document Ref:** 4863-CAU-XX-XX-RP-O-3001

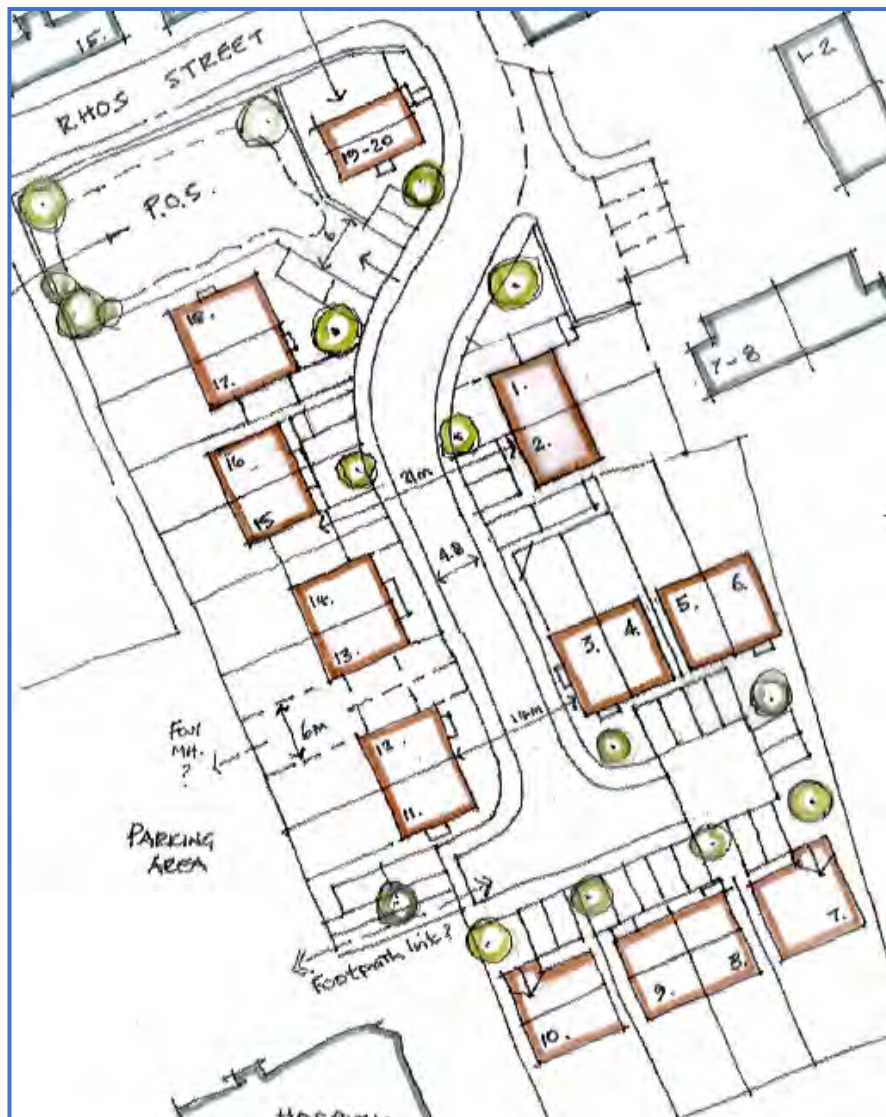
Figure 1 – Proposed Development Area

- 2.1.1 A development layout is yet to be finalised; however, it is anticipated the development will comprise of approximately twenty residential detached and semi-detached two storey houses, with associated access roads, private driveways, gardens and public open space.
- 2.1.2 An indicative development layout is presented as Figure 1; an extract is provided below.
- 2.1.3 No construction details, structural loads or site wide elevations have been received to date. It is assumed the building will be of traditional load bearing masonry wall construction.

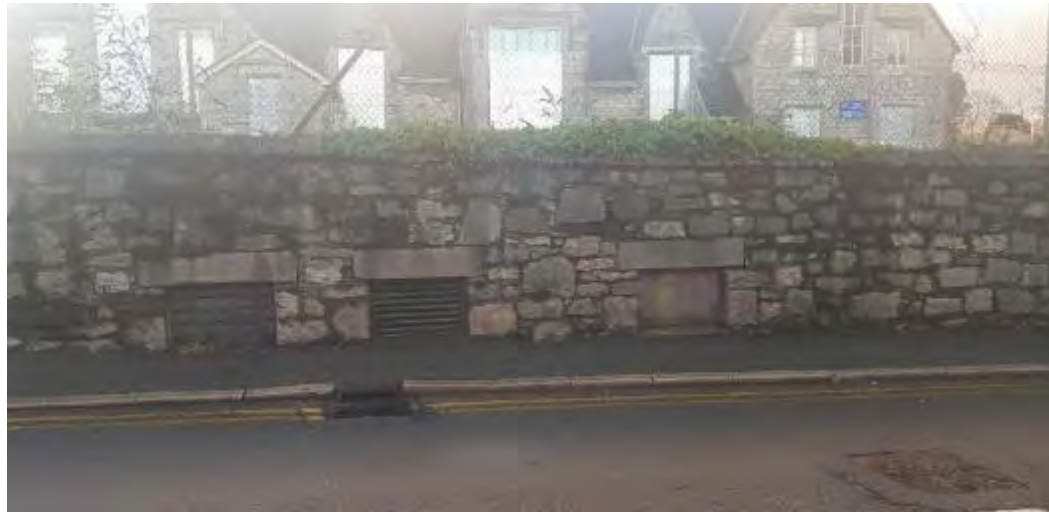
Existing Rhos Street retaining wall with three openings, with original school building in the background.

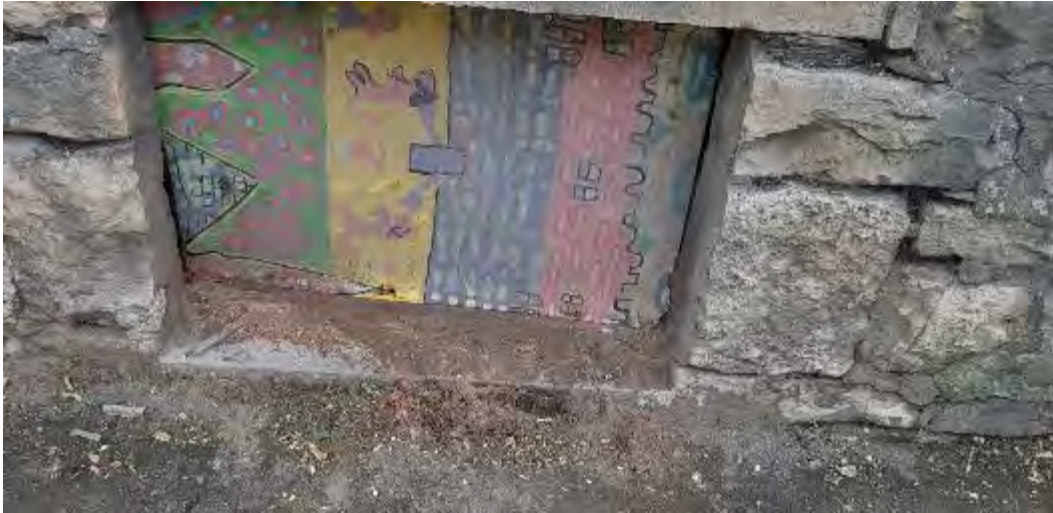
One of the sealed up openings within retaining wall along northern boundary (Rhos Street).

9.2.3 A former basement has been identified in the north of the site, beneath the playground it is estimated that this is 6m in length and stretching back approximately 4m from the retaining wall fronting Rhos Street and approximately 2.2m in height. However, this will need to be confirmed through a detailed survey. It is anticipated that this will require filling to allow the proposed development to progress. However, altering the lateral loading on the retaining wall will need careful consideration and it is recommended that a structural survey is undertaken on the basement and the rest of the retaining wall.

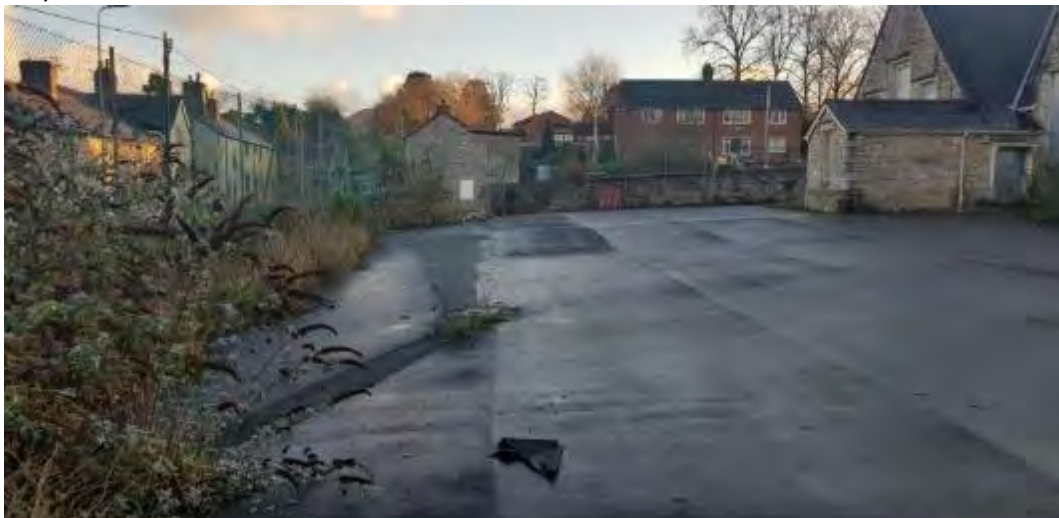
Playground above Rhos Street Retaining wall, no evidence of infilled basement, although playground has been resurfaced.

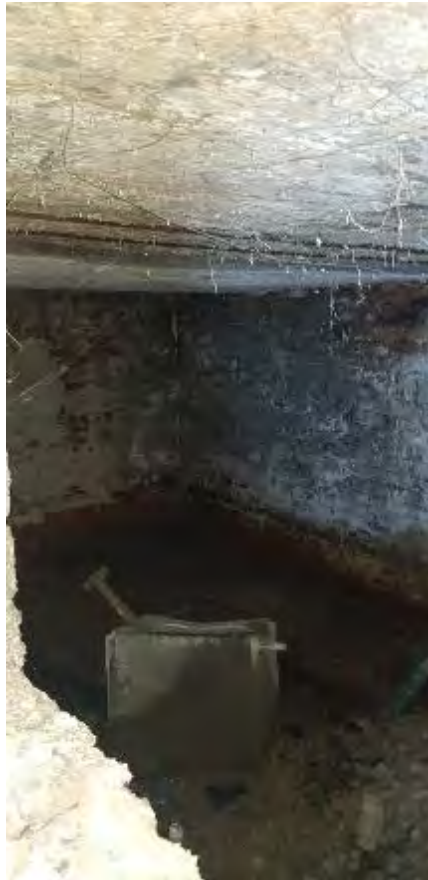
<p>the north, with three shuttered/boarded 'window' type openings noted. These lead into a basement/undercroft feature approximately 6m in length and stretching back approximately 4m from the retaining wall and approximately 2.2m in height. It is understood that this feature was originally accessed from the playground via steps which have now been infilled. Anecdotal evidence suggests it was used as a 'coke/coal' store for the school.</p>
Topography	<p>The general topography slopes down from east to west by approximately 2m. The site also slopes from the north up to the south by approximately the same. However, the site itself is generally level, development platforms have been created and the site is supported by a number of small retaining walls.</p>
Site Access and Security	<p>The site is currently accessed off Rhos Street via a locked gate from a shared access road with the adjacent residential dwellings. The site is generally surrounded by a mixture of low stone walling or wooden fencing. However, temporary 'herras' type security fencing currently secures the site.</p>

View looking east into the basement feature (Coke Store).

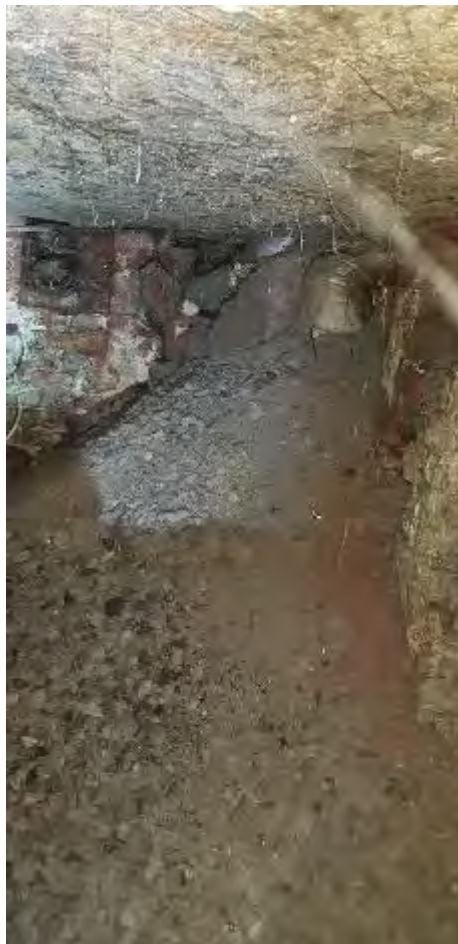
Possible former steps into basement feature, filled with lean mix/aggregate.

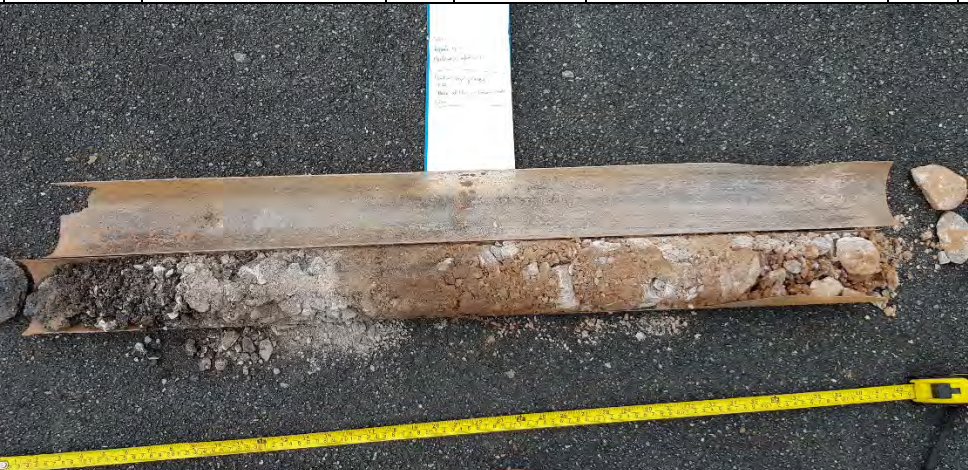
Project:		Ref:		
			<b>Former Rhos Street School, Ruthin</b>		<b>WS1</b>		
Boring date:		Logged by:	Client:		Project ID:		
18.10.2021		DK	<b>ADRA</b>		4863		
Elevation			Coordinates				
<b>Depth (m)</b>		<b>Description</b>					
<b>from</b>	<b>to</b>						
0	0.2	Asphalt [HARDSTANDING].

0.2	0.4	Light grey fine to coarse sandy gravel. Gravel fine to coarse subangular of limestone. [HARDCORE]					
0.4	1.45	Light grey slightly clayey fine to coarse sandy gravel. Gravel fine to coarse subangular of limestone. [HARDCORE]					
Refused at 1.45m							
Samples: Env 0.5m-0.7m							
<b>Notes.</b>		Borehole scanned with CAT prior to drilling					
		Window Samples formed by Exploration Ltd under supervision of Caulmert Limited					
		Groundwater – No groundwater encountered.					
<b>Sampling &amp; Recovery Details (m)</b>				<b>SPT test details</b>			
<b>Depth (m)</b>		<b>Recovery</b>	<b>comments</b>	<b>Depth</b>	<b>Blow count</b>	<b>N</b>	<b>Comment</b>
<b>from</b>	<b>to</b>	<b>(%)</b>		<b>(m)</b>			
0	1	100		1-1.45m	4,5; - 48,2 (0mm)	50+	Refused

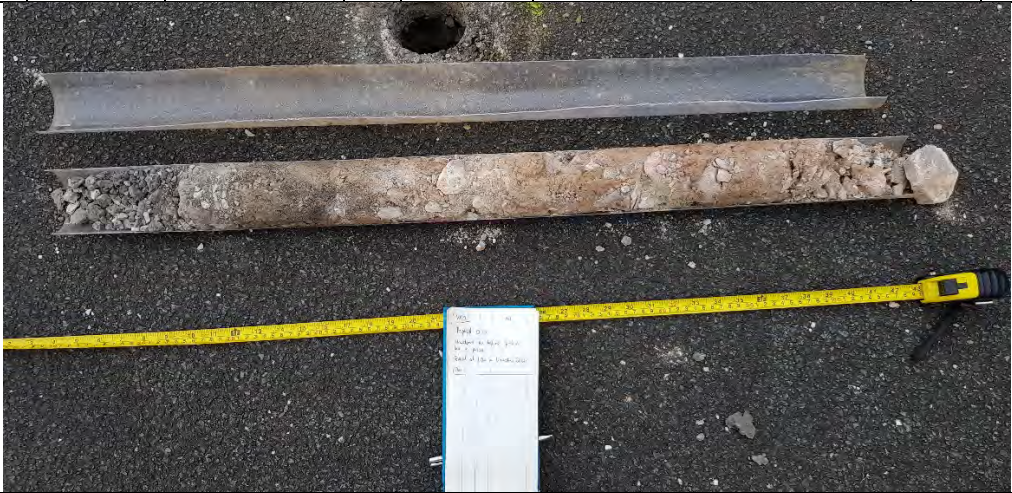
0.2	1.45	Light grey to pinkish grey fine to coarse sandy gravel. Gravel fine to coarse subangular of limestone. [HARDCORE]					
Refused at 1.45m							
Samples: -							
<b>Notes.</b>		Borehole scanned with CAT prior to drilling Window Samples formed by Exploration Ltd under supervision of Caulmert Limited Groundwater – No groundwater encountered.					
<b>Sampling &amp; Recovery Details (m)</b>			<b>SPT test details</b>				
<b>Depth (m)</b>		<b>Recovery (%)</b>	<b>comments</b>	<b>Depth (m)</b>	<b>Blow count</b>	<b>N</b>	<b>Comment</b>
<b>from</b>	<b>to</b>						
0	1	100		1-1.45m	6,6; -5,45 (10mm)	50+	Refused

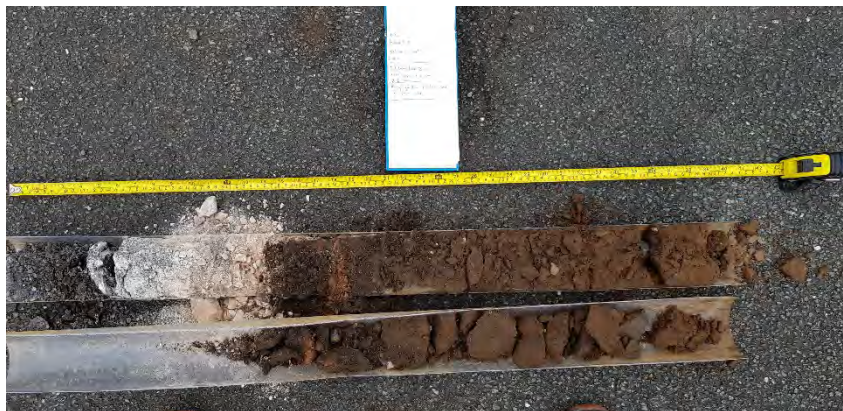
Project: <b>Former Rhos Street School, Ruthin</b>		Ref: <b>WS3</b>	
Boring date: 18.10.2021		Logged by: DK	Client: <b>ADRA</b>		Project ID: 4863	
Elevation			Coordinates			
<b>Depth (m)</b>		<b>Description</b>				
<b>from</b>	<b>to</b>					
0	0.2	Asphalt [HARDSTANDING].

0.2	0.4	Light grey fine to coarse sandy gravel. Gravel fine to coarse subangular of limestone. [HARDCORE]				
0.4	1.00	Dark brown fine SAND [MADE GROUND/RELIC TOPSOIL]

1.00	1.45	Light brown fine SANDSTONE or Cobble? [KINNERTON SANDSTONE FORMATION]				
Refused at 1.45m						
Env: 0.5-0.8 (m)						
<b>Notes.</b>		Borehole scanned with CAT prior to drilling				
		Window Samples formed by Exploration Ltd under supervision of Caulmert Limited				
		Groundwater – No groundwater encountered.				
<b>Sampling &amp; Recovery Details (m)</b>				<b>SPT test details</b>		
<b>Depth (m)</b>		<b>Recovery (%)</b>	<b>comments</b>	<b>Depth (m)</b>	<b>Blow count</b>	<b>N</b>
<b>from</b>	<b>to</b>					<b>Comment</b>
0	1	100		0-0.45	4,6: - 8,39,3 9(0mm)	50+
					6

TP Ref.	Response Zone (m bgl)	Response Zone Strata	Infiltration Rate (m/s)
WS3	0.5-1.0	Residual Soils/Kinnerton Sandstone	$7.6 \times 10^{-6}$
WS5	0.5-1.0	Residual Soils/Kinnerton Sandstone	$1.60 \times 10^{-6}$
WS10	0.8-1.8	Residual Soils/Kinnerton Sandstone	$2.4 \times 10^{-5}$

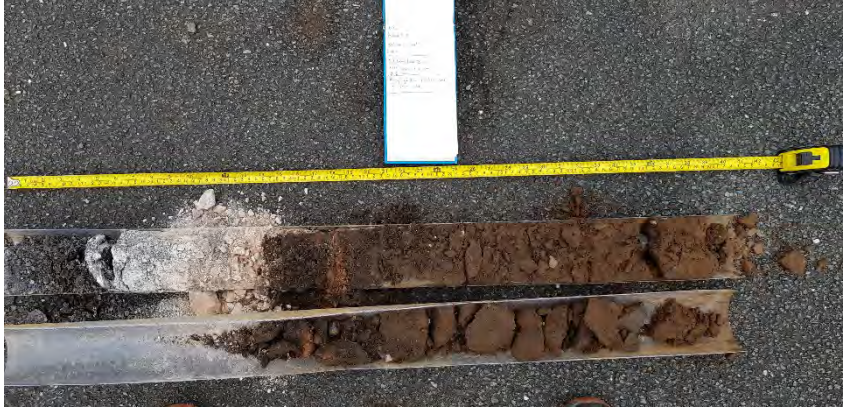
Project: <b>Former Rhos Street School, Ruthin</b>		Ref: <b>WS4</b>	
Boring date: 18.10.2021		Logged by: DK	Client: <b>ADRA</b>		Project ID: 4863	
Elevation			Coordinates			
<b>Depth (m)</b>		<b>Description</b>				
<b>from</b>	<b>to</b>					
0	0.1	Asphalt [HARDSTANDING].

0.1	0.4	Light grey fine to coarse sandy gravel. Gravel fine to coarse subangular of limestone. [HARDCORE]				
0.4	0.6	Brown silty Sand with rare gravel. Gravel medium subangular of limestone. [MADE GROUND/RELIC TOPSOIL]

1.00	2.45	Red brown fine SAND. Below 1.60m grading into extremely weak fine SANDSTONE. [KINNERTON SANDSTONE FORMATION]				
Refused at 2.45m						
Samples: Env 0.4-0.6m, Small Bulk 0.5-1.0m						
<b>Notes.</b>		Borehole scanned with CAT prior to drilling				
		Window Samples formed by Exploration Ltd under supervision of Caulmert Limited				
		Groundwater – No groundwater encountered.				
<b>Sampling &amp; Recovery Details (m)</b>				<b>SPT test details</b>		
<b>Depth (m)</b>		<b>Recovery (%)</b>	<b>comments</b>	<b>Depth (m)</b>	<b>Blow count</b>	<b>N</b>
<b>from</b>	<b>to</b>					<b>Comment</b>
0	1	100		1-1.45m	2,2: - 1,2,1,2,	6
1	2	100		2-2.45	4,6: - 7,27,16(50mm)	50+

7.3.8 The Made Ground/relic topsoil deposit within WS4 0.4m-0.6m was found to have a slight exceedance in Benz(a)anthracene with respect to GAC residential with plant uptake (1% SOM). When the WS9 0.1-0.2 sample is removed from the data set the 95<sup>th</sup> percentile is below the GAC and therefore the Made Ground/Relic Topsoil at WS4 and is unlikely to be a significant risk to end users and no further action is required.

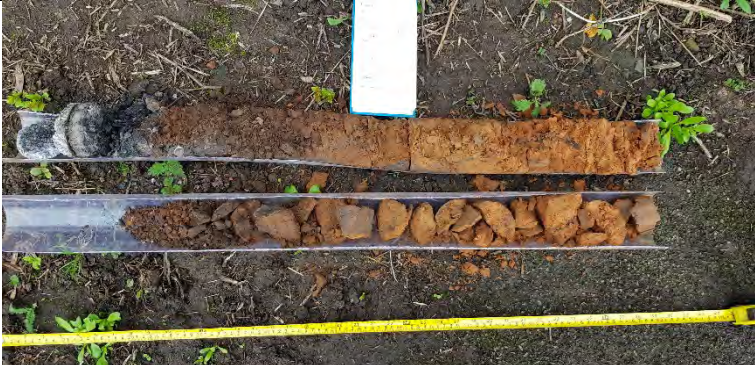
0.1	0.2	Tarmac [HARDSTANDING]					
0.2	0.4	Dark brown fine sand with rare fine gravel size fragment of ash and rare medium sized gravel of brick. [MADE GROUND]

0.4	0.6	Brown fine SAND. [RESIDUAL SOIL – TOTALLY WEATHERED KINERTON SANDSTONE FORMATION]					
0.6	1.45	Orangish brown fine SAND grading into extremely weak SANDSTONE. [KINNERTON SANDSTONE FORMATION]					
Refused at 1.45m							
Sampling: Env 0.2-0.4m, Small Bulk 0.6-1.0m							
<b>Notes.</b>		Borehole scanned with CAT prior to drilling					
		Window Samples formed by Exploration Ltd under supervision of Caulmert Limited					
		Groundwater – No groundwater encountered.					
<b>Sampling &amp; Recovery Details (m)</b>			<b>SPT test details</b>				
<b>Depth (m)</b>		<b>Recovery (%)</b>	<b>comments</b>	<b>Depth (m)</b>	<b>Blow count</b>	<b>N</b>	<b>Comment</b>
<b>from</b>	<b>to</b>						
0	1	100		1-1.45m	5,4: - 7,6,8,29(10mm)	50+	Refused

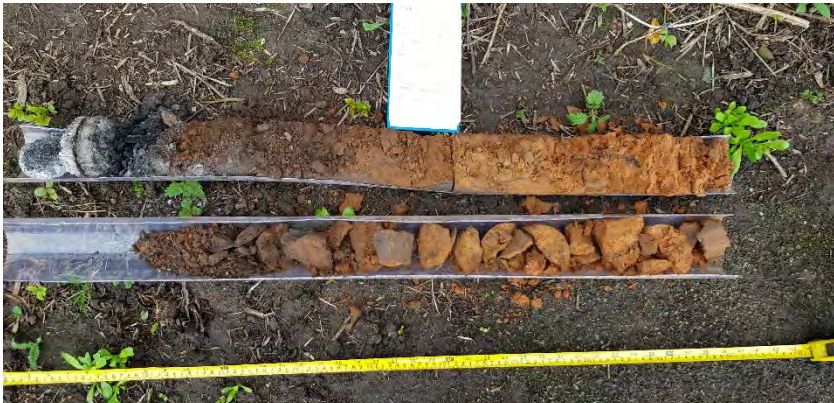
0.1		0.2	Tarmac [HARDSTANDING]						
0.2		0.3	Dark brown fine sand with rare fine gravel size fragment of ash and rare medium sized gravel of brick. [MADE GROUND]

0.4		1.45	Brown fine SAND. [RESIDUAL SOIL – TOTALLY WEATHERED KINERTON SANDSTONE FORMATION]						
Refused at 1.45m									
<b>Notes.</b>		Borehole scanned with CAT prior to drilling							
		Window Samples formed by Exploration Ltd under supervision of Caulmert Limited							
		Groundwater – No groundwater encountered.							
<b>Sampling &amp; Recovery Details (m)</b>				<b>SPT test details</b>					
<b>Depth (m)</b>		<b>Recovery (%)</b>	<b>comments</b>		<b>Depth (m)</b>	<b>Blow count</b>		<b>N</b>	<b>Comment</b>
<b>from</b>	<b>to</b>								
0	1	100			1-1.45m	4,5: - 5,6,8,12		31

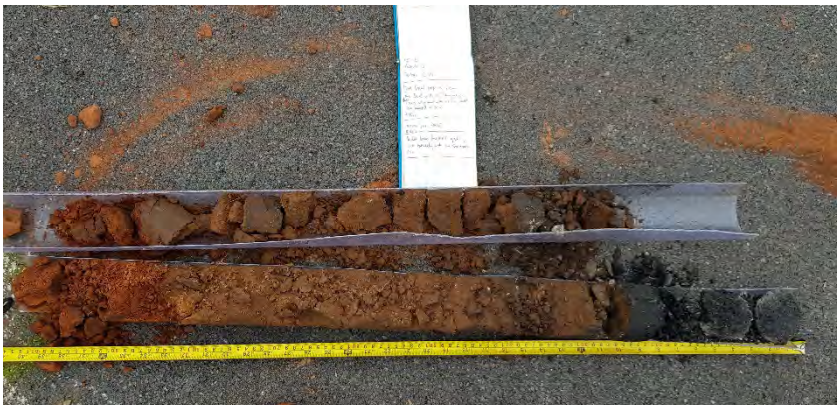
0.1	0.2	Tarmac [HARDSTANDING]				
0.2	0.4	Brown fine sand with thin laminae of dark brown silty sand with rare fine gravel size fragment of brick. [MADE GROUND]

0.4	0.8	Brown fine SAND [RESIDUAL SOIL – TOTALLY WEATHERED KINERTON SANDSTONE FORMATION]				
0.8	1.45	Reddish brown fine SAND grading into extremely weak fine SANDSTONE [KINERTON SANDSTONE FORMATION]				
Refused at 1.45						
Sampling: Small Bulk 0.5m-0.8m						
<b>Notes.</b>		Borehole scanned with CAT prior to drilling				
		Window Samples formed by Exploration Ltd under supervision of Caulmert Limited				
		Groundwater – No groundwater encountered.				
<b>Sampling &amp; Recovery Details (m)</b>			<b>SPT test details</b>			
<b>Depth (m)</b>	<b>Recovery</b>	<b>comments</b>	<b>Depth</b>	<b>Blow count</b>	<b>N</b>	<b>Comment</b>
<b>from</b>	<b>(%)</b>		<b>(m)</b>			
0	1		1-1.45m	2,2: - 5,13,21,11(10mm)	50+	Refused

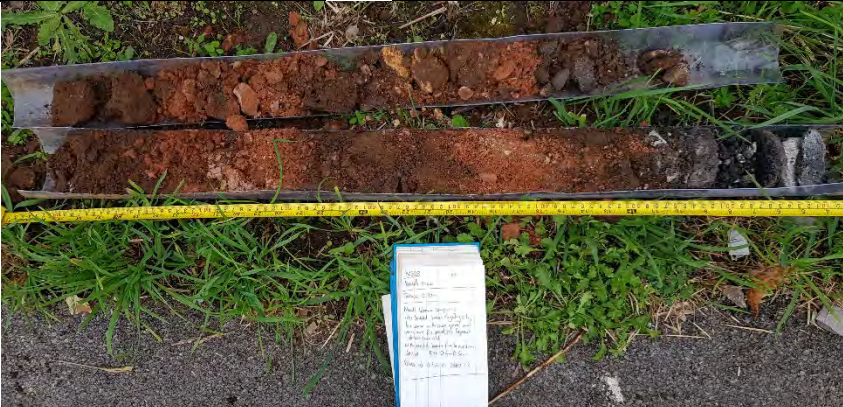
Project:		Ref:			
		<b>Former Rhos Street School, Ruthin</b>		<b>WS8</b>			
Boring date: 18.10.2021		Logged by: DK	Client: <b>ADRA</b>		Project ID: 4863		
Elevation			Coordinates				
<b>Depth (m)</b>		<b>Description</b>					
<b>from</b>	<b>to</b>						
0	0.1	Asphalt [HARDSTANDING].

0.1	0.2	Tarmac [HARDSTANDING]					
0.2	1.45	Brown slightly silty fine sand with rare gravel and very rare gravel size fragment of ash/charcoal interbedded with reddish brown fine to medium sand. [MADE GROUND]					
Refused at 1.45m							
Sampling: Env 0.4m-0.6m							
<b>Notes.</b>		Borehole scanned with CAT prior to drilling					
		Window Samples formed by Exploration Ltd under supervision of Caulmert Limited					
		Groundwater – No groundwater encountered.					
<b>Sampling &amp; Recovery Details (m)</b>			<b>SPT test details</b>				
<b>Depth (m)</b>		<b>Recovery (%)</b>	<b>comments</b>	<b>Depth (m)</b>	<b>Blow count</b>	<b>N</b>	<b>Comment</b>
<b>from</b>	<b>to</b>						
0	1	100		1-1.45m	5,9: - 13,19,18 (20mm)	50+	Refused

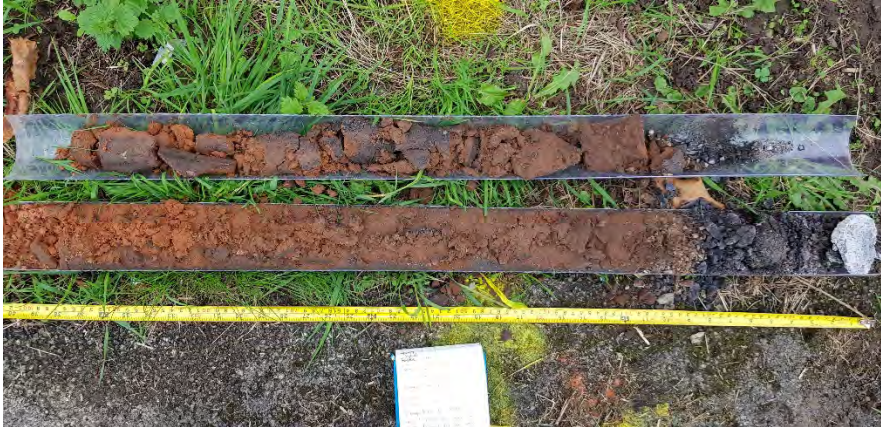
0.1	0.2	Tarmac [HARDSTANDING]					
0.2	0.80	Brown fine SAND [RESIDUAL SOIL – TOTALLY WEATHERED KINERTON SANDSTONE FORMATION]					
0.80	1.00	Orangish brown fine SAND grading into extremely weak fine SANDSTONE [KINERTON SANDSTONE FORMATION]					
Refused 1.45m							
Sampling: Env 0.1m-0.2m, Small Bulk 0.8-1.0m							
<b>Notes.</b>		Borehole scanned with CAT prior to drilling Window Samples formed by Exploration Ltd under supervision of Caulmert Limited Groundwater – No groundwater encountered.					
<b>Sampling &amp; Recovery Details (m)</b>			<b>SPT test details</b>				
<b>Depth (m)</b> <b>from</b>	<b>to</b>	<b>Recovery (%)</b>	<b>comments</b>	<b>Depth (m)</b>	<b>Blow count</b>	<b>N</b>	<b>Comment</b>
0	1	100		1-1.45m	3,7: - 14,22,14(20mm)	50+	Refused

7.3.7 The Tarmac sample from WS9 (0.1m-0.2m) was found to have PAHs speciation's in exceedances with respect to GAC residential with plant uptake (1% SOM) and GAC Public Open Space (1% SOM) these PAH chemicals are typically a component within binding agents in Tarmac of a certain age.

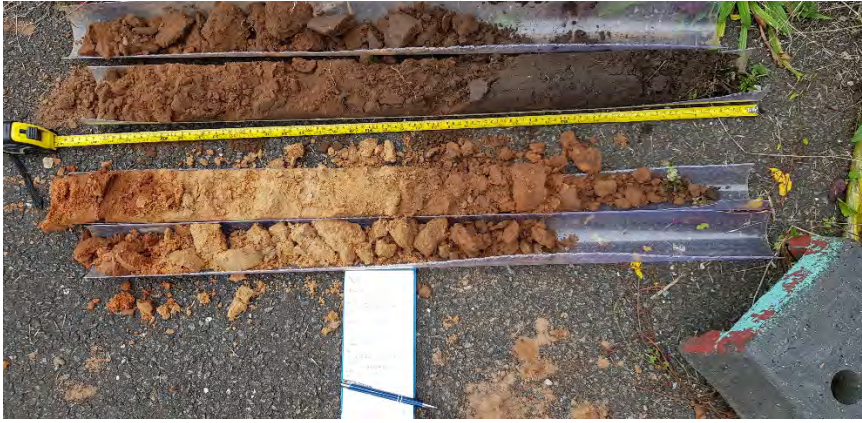
0.4	1.50	Brown fine SAND [RESIDUAL SOIL – TOTALLY WEATHERED KINERTON SANDSTONE FORMATION]					
1.50	1.85	Light creamy brown fine to medium SAND. Below 1.8m reddish brown to light reddish brown. [KINERTON SANDSTONE FORMATION]					
Refused at 1.85m							
Sampling: Env: 0.1m-0.3m Small Bulk 1.5m-2.0m							
<b>Notes.</b>		Borehole scanned with CAT prior to drilling					
		Window Samples formed by Exploration Ltd under supervision of Caulmert Limited					
		Groundwater – No groundwater encountered.					
<b>Sampling &amp; Recovery Details (m)</b>			<b>SPT test details</b>				
<b>Depth (m)</b>		<b>Recovery (%)</b>	<b>comments</b>	<b>Depth (m)</b>	<b>Blow count</b>	<b>N</b>	<b>Comment</b>
<b>from</b>	<b>to</b>						
0	1	100		1-1.45m	4,5: - 5,7,8,8	28	
1	1.8	100		1.8-2.45	14,11:-21,24,5 (0mm)	50+	Refused

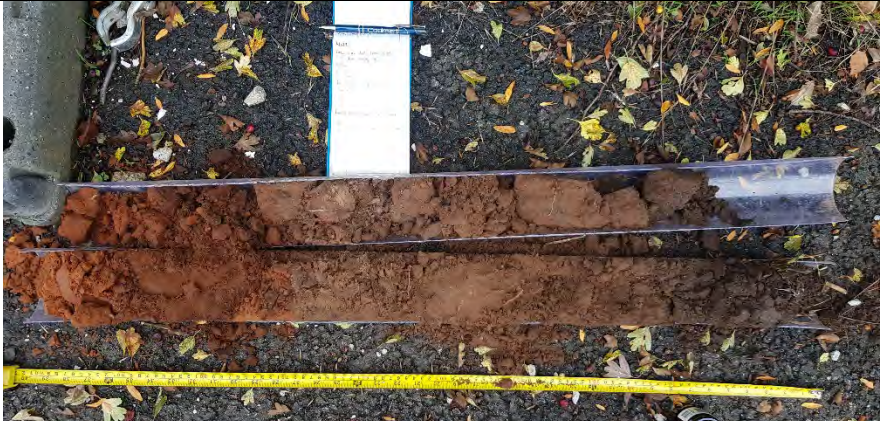
0.2		0.70	Brown fine SAND with rare rootlet. [RESIDUAL SOIL – TOTALLY WEATHERED KINERTON SANDSTONE FORMATION]						
0.70		1.00	Dark orangish brown fine SAND. [KINERTON SANDSTONE FORMATION]						
Refused at 1.45m									
Samples: Env: 0.4-0.6m Small Bulk 0.8-1.0m									
<b>Notes.</b>		Borehole scanned with CAT prior to drilling							
		Window Samples formed by Exploration Ltd under supervision of Caulmert Limited							
		Groundwater – No groundwater encountered.							
<b>Sampling &amp; Recovery Details (m)</b>				<b>SPT test details</b>					
<b>Depth (m)</b>		<b>Recovery (%)</b>	<b>comments</b>		<b>Depth (m)</b>	<b>Blow count</b>		<b>N</b>	<b>Comment</b>
<b>from</b>	<b>to</b>								
0	1	100			1-1.45m	25(50mm), 28,22(30mm)		50+	Refused
