Re: Proposed Residential Development at Land adjacent to Llanrwst Road, Gyffin, Conwy.

Summary

Caulmert Ltd were commissioned by Adra ("the Client") to undertake a pre-purchase ground investigation at land adjacent to Llanrwst Road, Gyffin, Conwy ("the Site"). A site location plan is provided as Figure 1, see over.

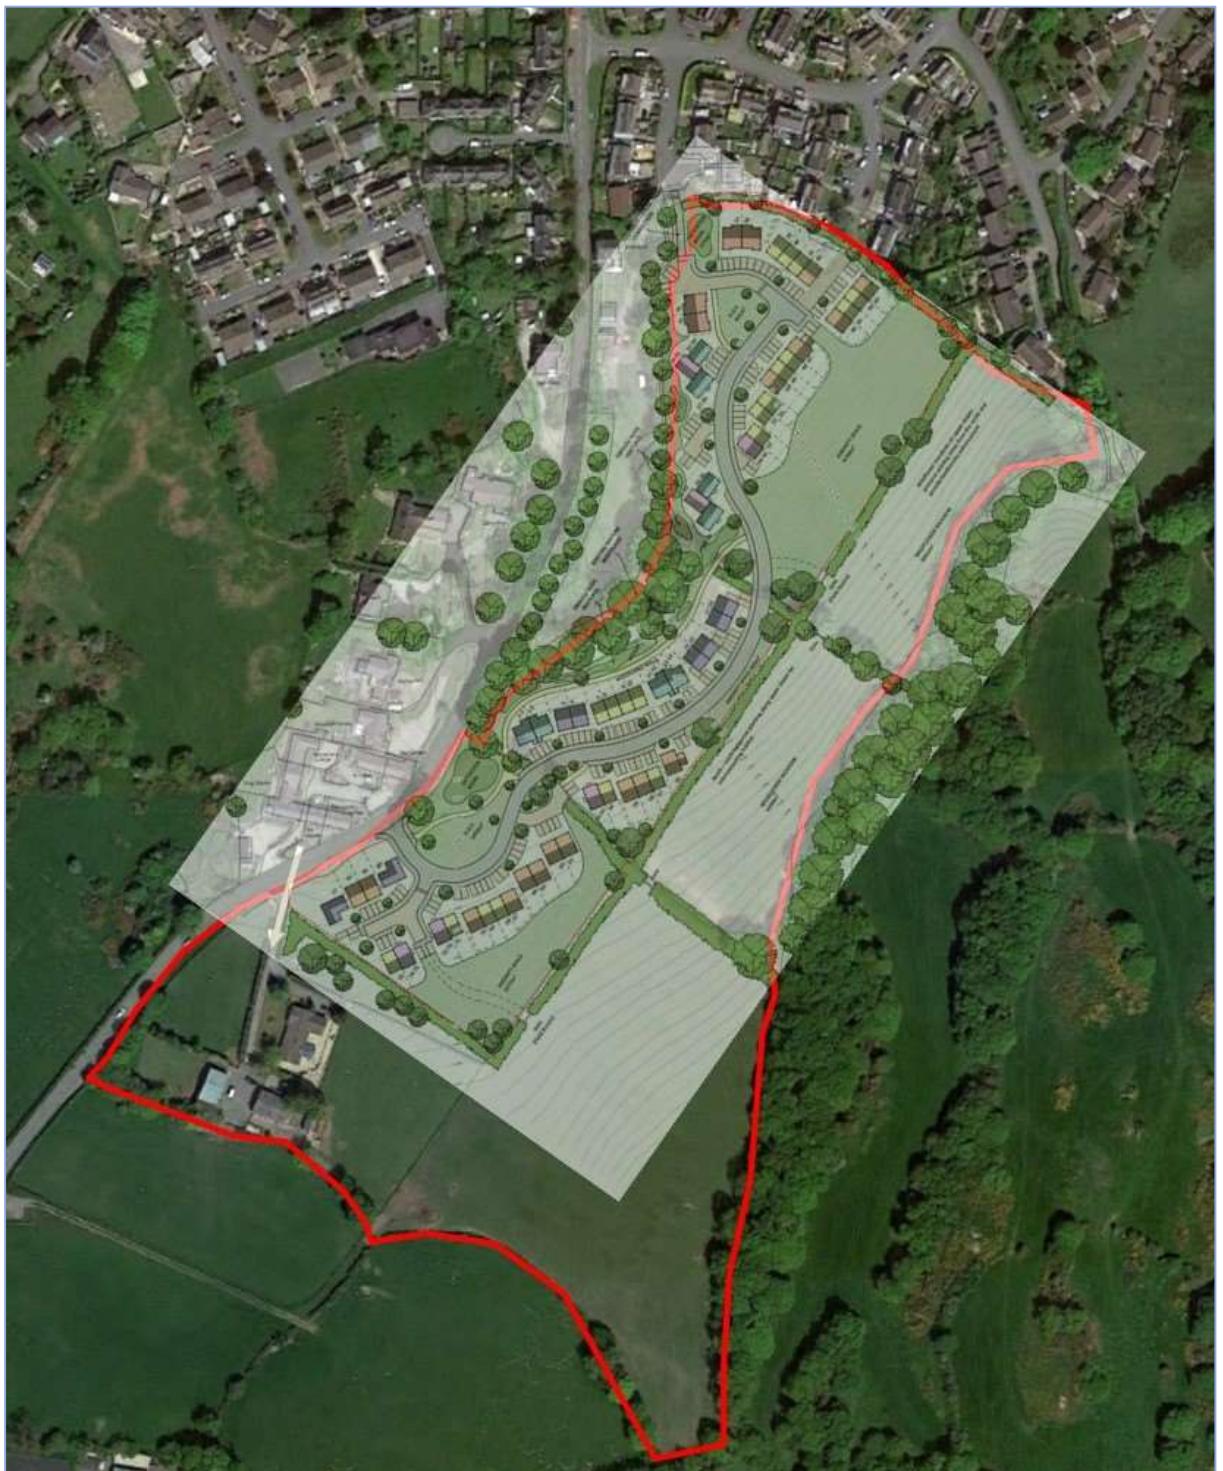
Figure 2: Indicative Site Layout.

The Client is proposing a housing scheme comprising 80 dwellings with associated gardens, public open space, amenity space, access roads, detention basins, retaining walls and stone gabions. The proposed layout is shown on Figure 2.

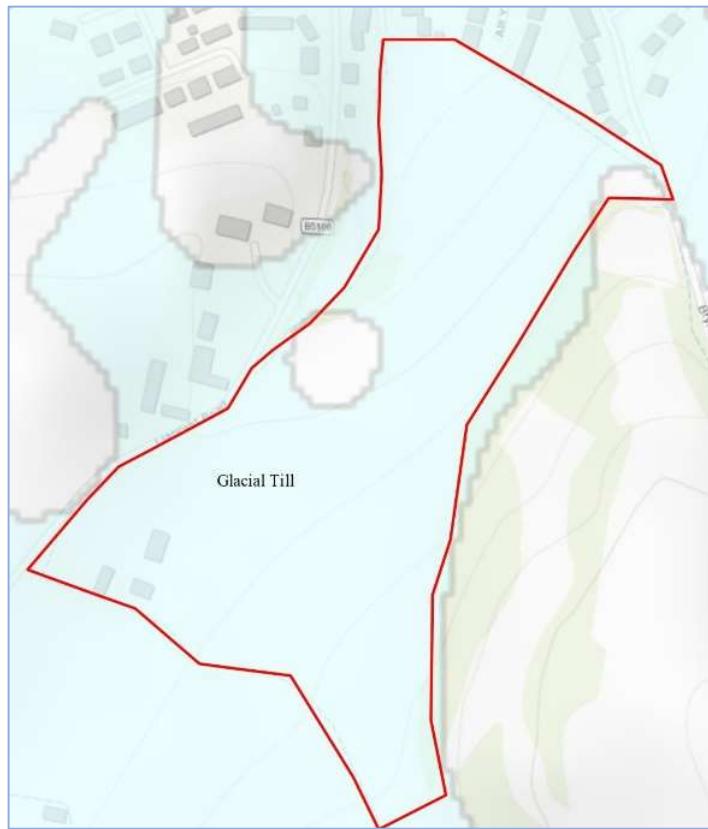
Figure 3a: Indicative Site Geology - Superficial

According to the published geology for the area (British Geological Survey 3D Viewer, and 1:50,000 BGS GeoIndex Viewer) the site is shown to be directly underlain by Glacial Till, a superficial deposits formed in the Quaternary and typically comprising of firm to stiff clay with variable sand and gravel content, with localised bands of sand and gravel.

In general, the bedrock ground conditions encountered during the ground investigation reflected those detailed within the published geology. However, the observed superficial deposits differed from the published geology, with the Glacial Till, not recorded across the majority of the site..

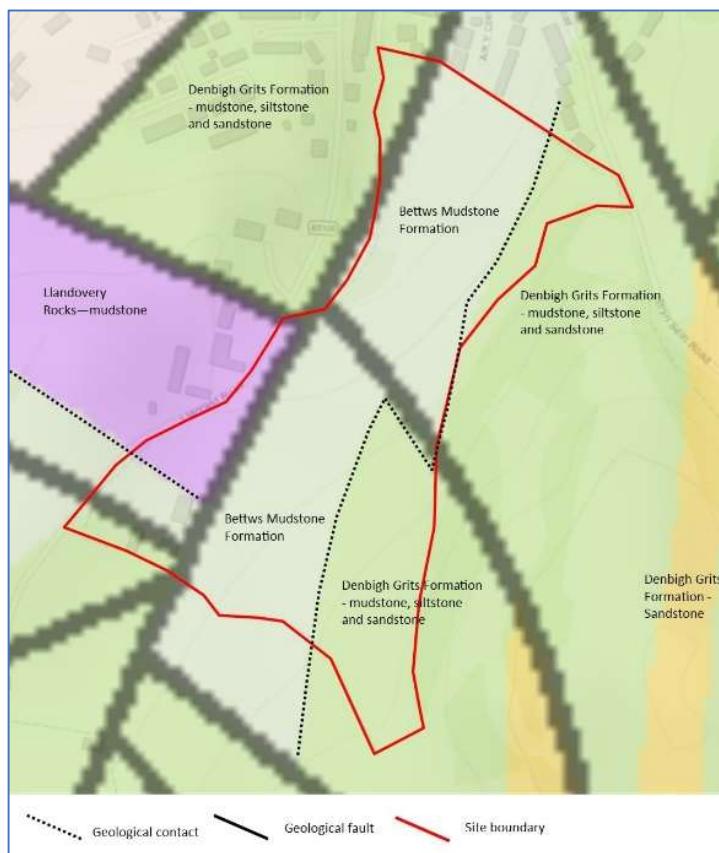
Figure 3b: Indicative Site Geology - Bedrock

The BGS maps shows that the superficial deposits are underlain by the Bettws Mudstone Formation across the majority of the site , with the Denbigh Grits Formation outcropping in the east and far south of the site and the Llandovery Rocks possibly outcropping in the central western area of the site. All formations are sedimentary of the Silurian period.

There is an inferred fault crossing the centre of the site from the south-east to north-west and another fault follows approximately the western boundary of the site from the south-west to the north-east. There are another two faults of direction south-east to northwest in the western part of the site, extending offsite

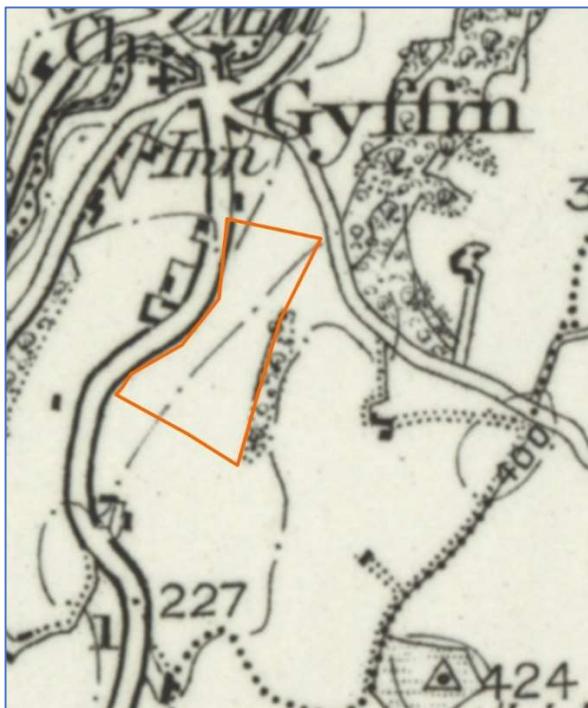
Figure 4a. 1885-1900

The 1885-1971 OS historical maps show the site to be agricultural land, bounded by Llanrwst Road with a number of buildings (possibly agricultural) to the west, wooded elevated area to the east, and agricultural land to the south and to the north. From 1888 the site is split up into 3 parcels of land. A quarry is mapped to the west of the site on map between 1888 and 1913.

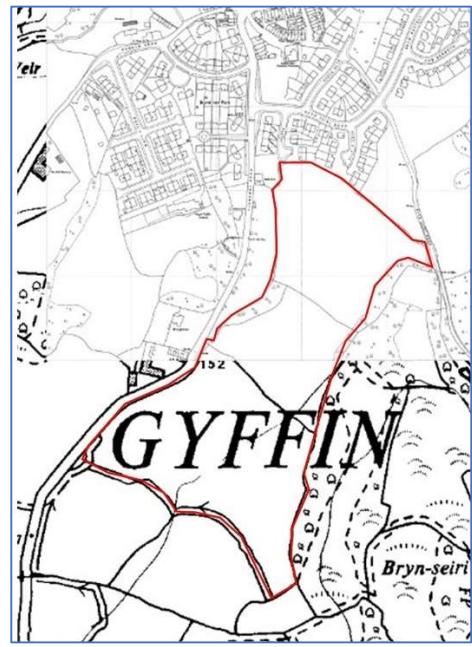
Figure 4f. 1971-1980

The housing estate to the north of the site was built between 1971 and 1980 and is shown on pre 1980 historical map.

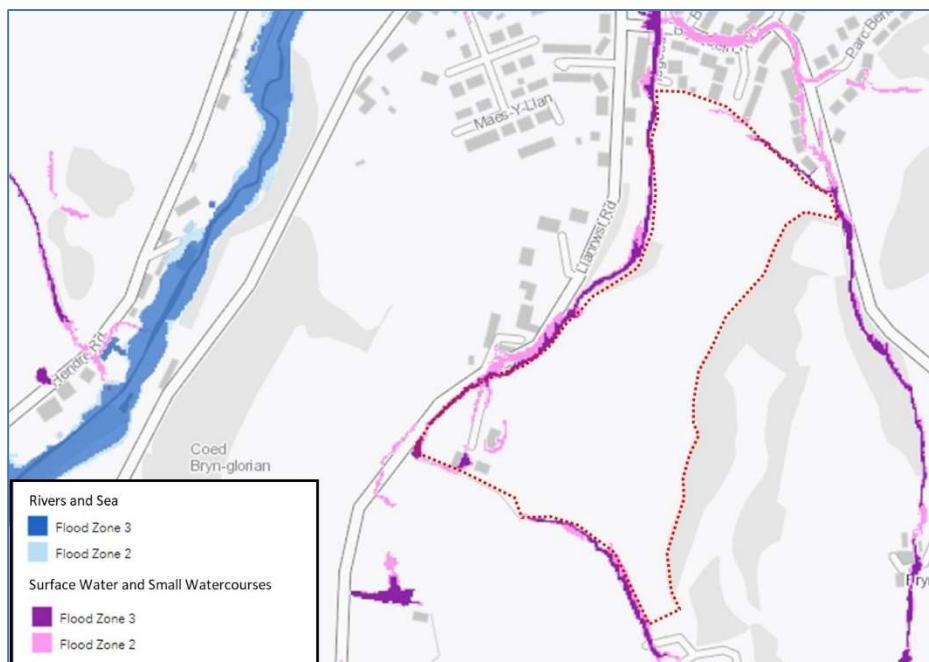
Figure 6. Flood risk from rivers, surface waters and small watercourses map (extracted from The Development Advice Map – Natural Resources Wales website).

The site is not in the area at risk from flooding from rivers, surface water and small watercourses. However, areas at risk from flooding are identified along the site's western, north-eastern and southern site boundaries.

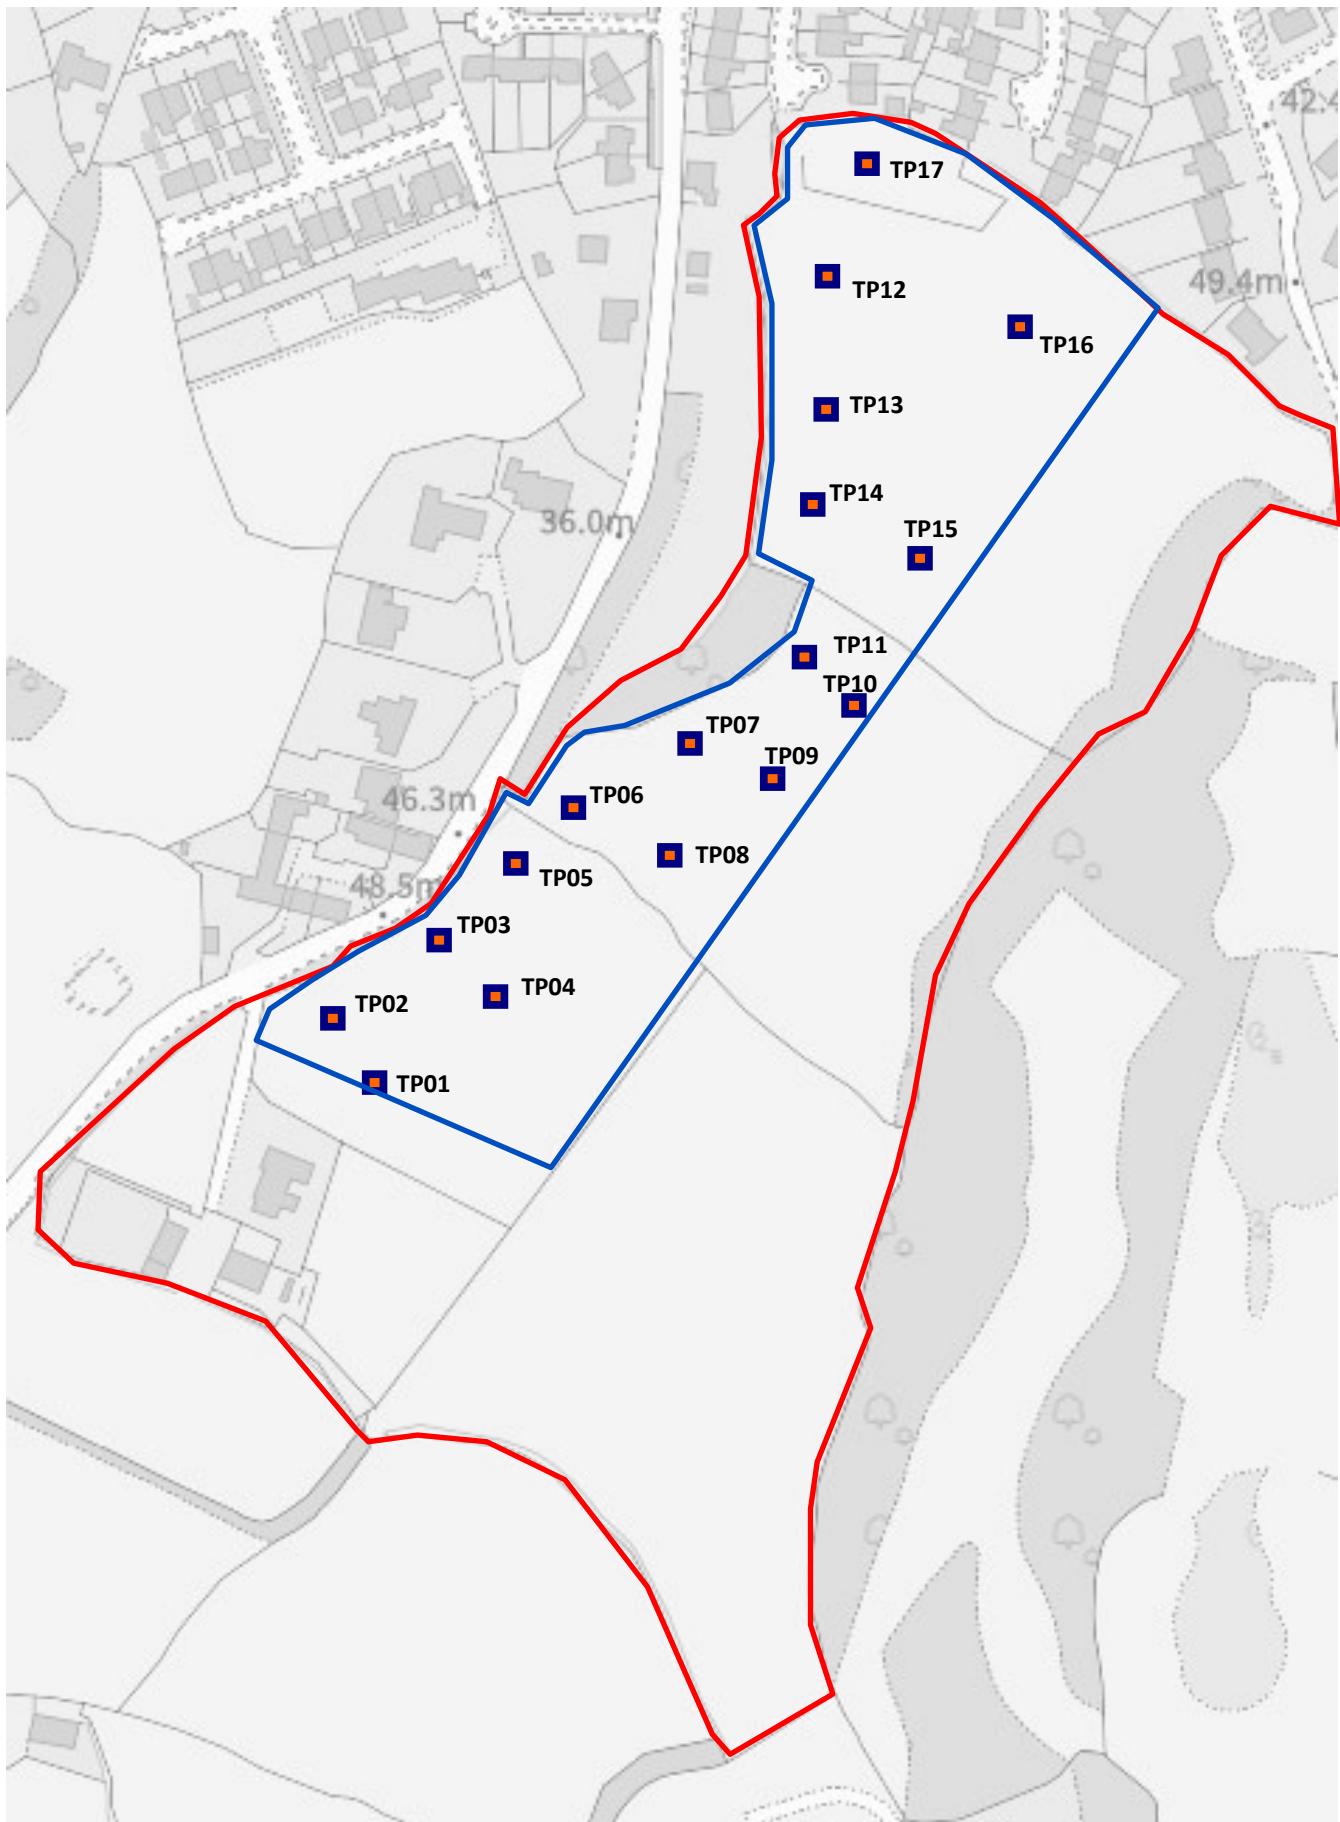
Exploratory Holes Location Plan

The position of the exploratory holes were selected by Caulmert to provide a wide coverage of information on the site area. An exploratory hole location plan is presented in Appendix A.

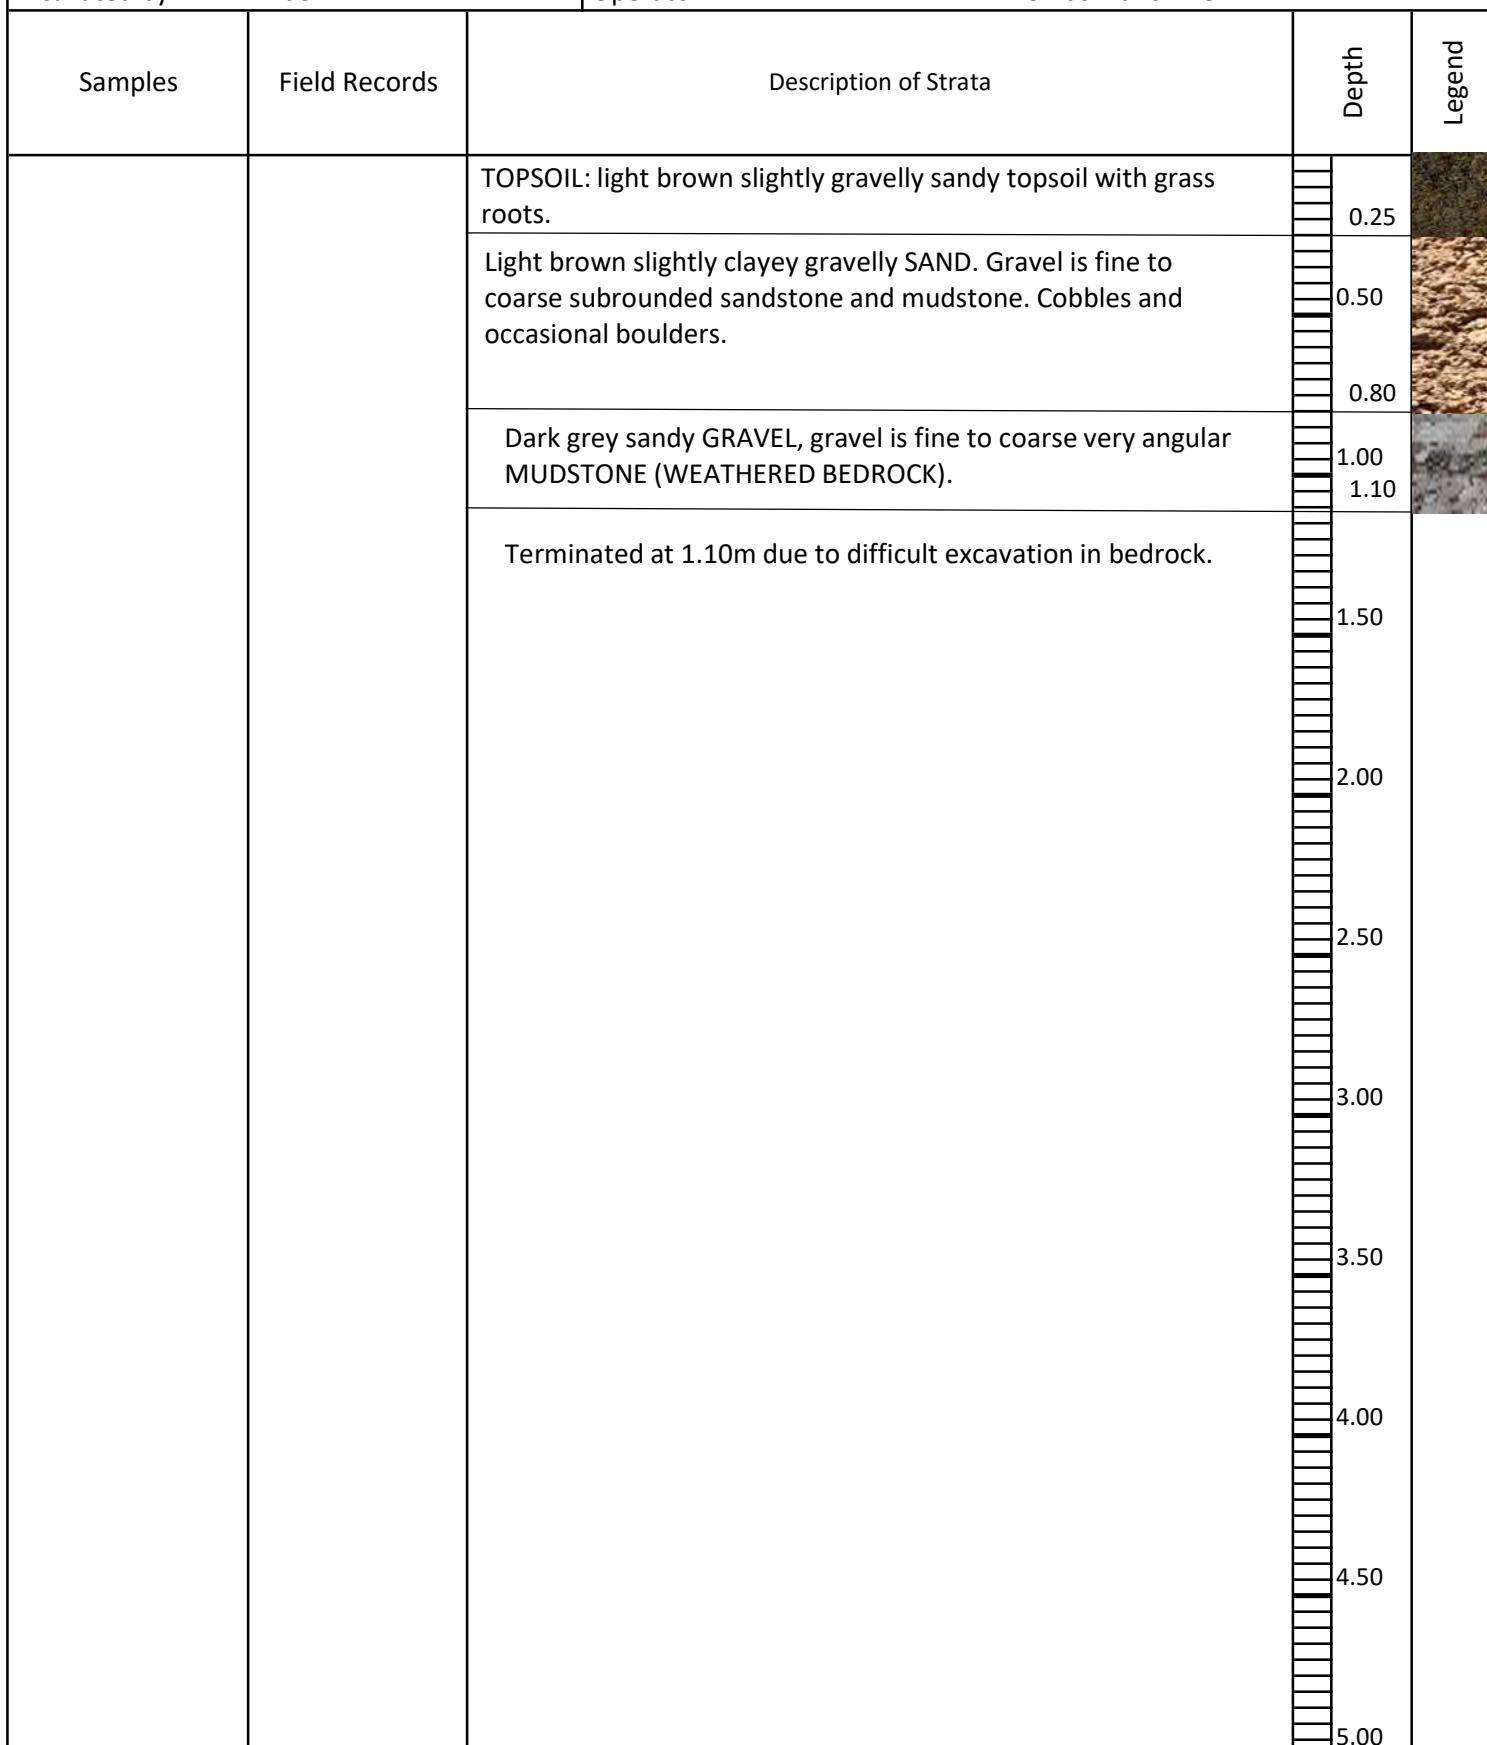
TP01

The trial pits TP01-TP17 were excavated with a JCB backhoe excavator to maximum depths of between 0.9mbgl (below ground level) and 3.1mbgl.

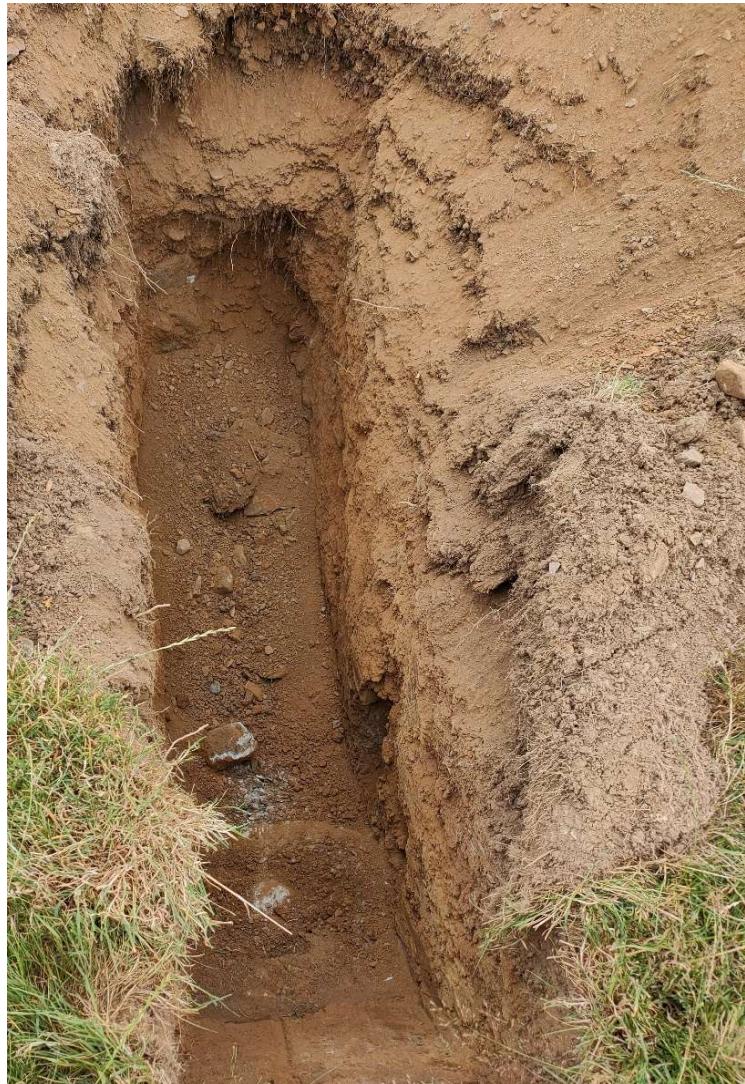
TP04

Gravel of grey sandstone

Highly to Moderately Weathered Bedrock - encountered at each test location from between 0.15m and 3m bgl down to the base of trial pits at depths of between 0.9m and 3.1m bgl. Represented in general by highly to moderately weathered bedrock retrieved as brown to light grey/dark grey sandy angular to very angular gravel of grey/dark grey mudstone. The bedrock of sandstone was observed in TP04, TP15, TP16 and TP17.

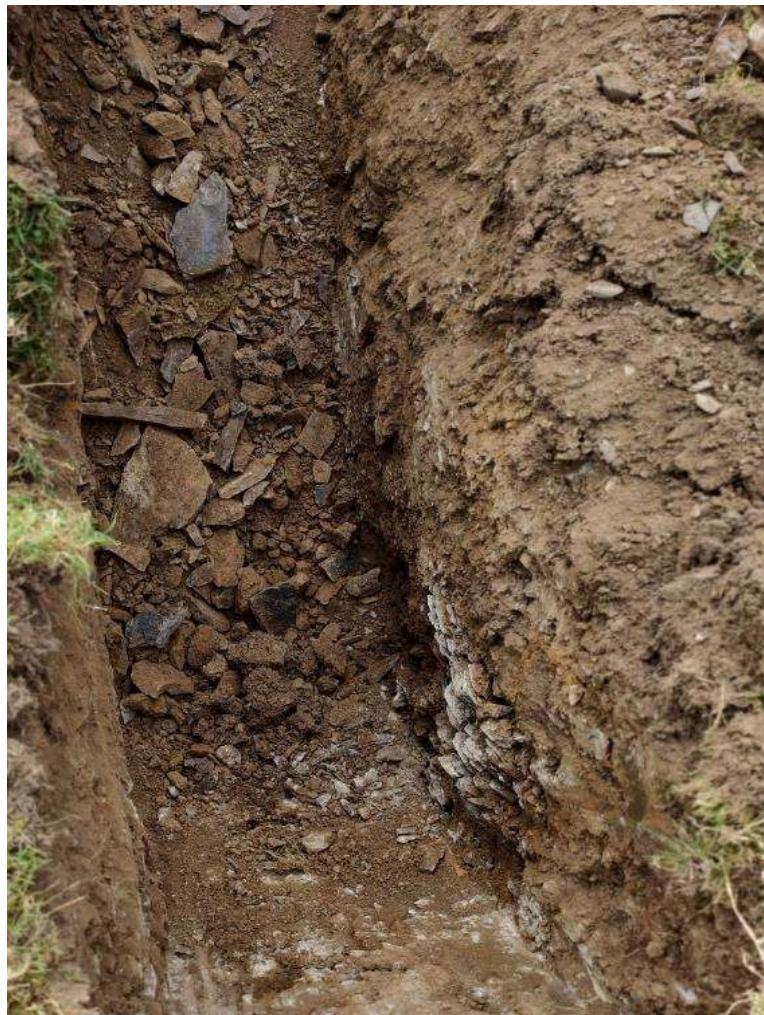
TP06

Gravel of mudstone

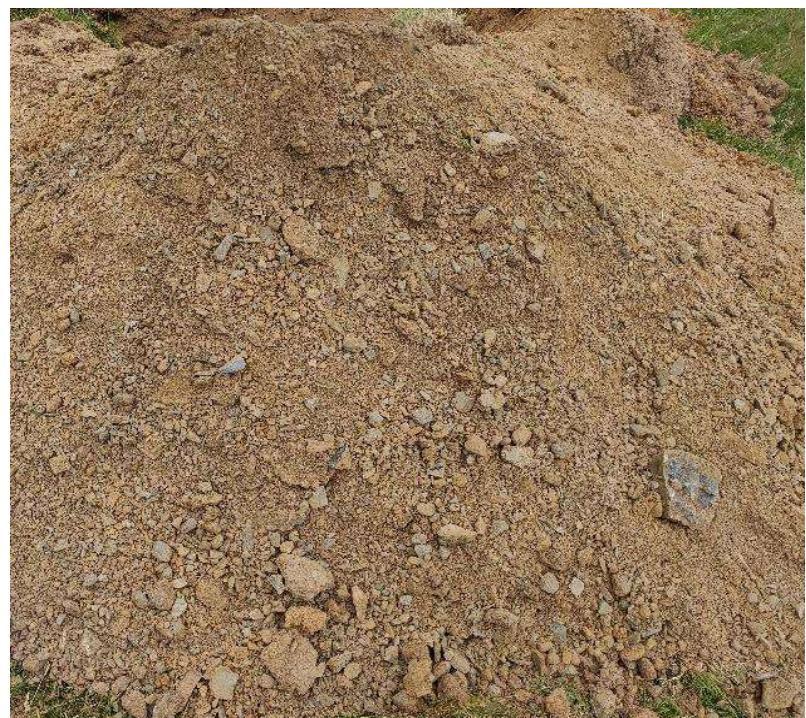
TP15

Gravel of sandstone

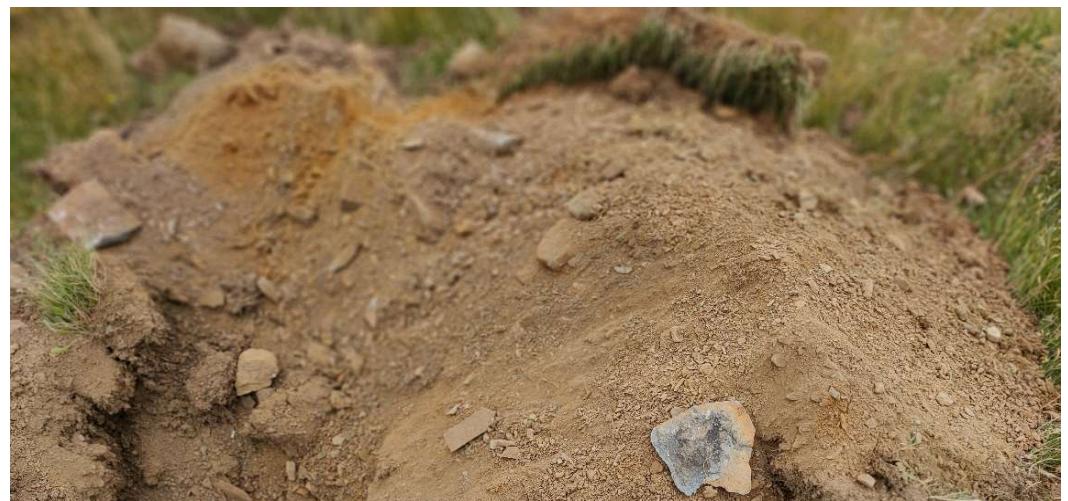
Hole ID:
TP16

Gravel of sandstone
