Bodnant Avenue Housing Site

Phase I and Phase II Geo-Environmental Report

Document Reference: 5986-CAU-XX-XX-RP-V-3001

October 2024

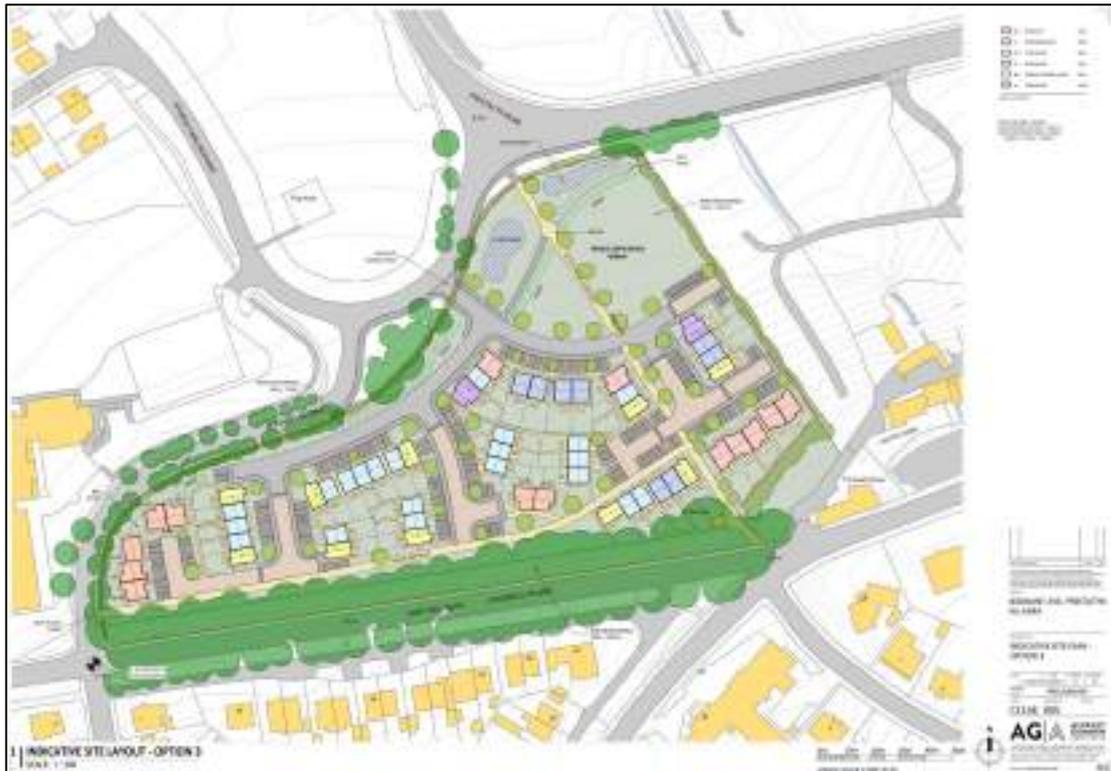
Figure 1: Proposed development area.

- 2.1.1 The proposed development will consist of a housing scheme comprising of approximately 62no. affordable dwellings with private gardens, access roads and public open space over 2.6 acres of land.
- 2.1.2 The development will comprise low-rise properties of varying sizes. No construction details or structural loads have been made available at the time of writing this report. A initial development layout is presented as Figure 1 below:

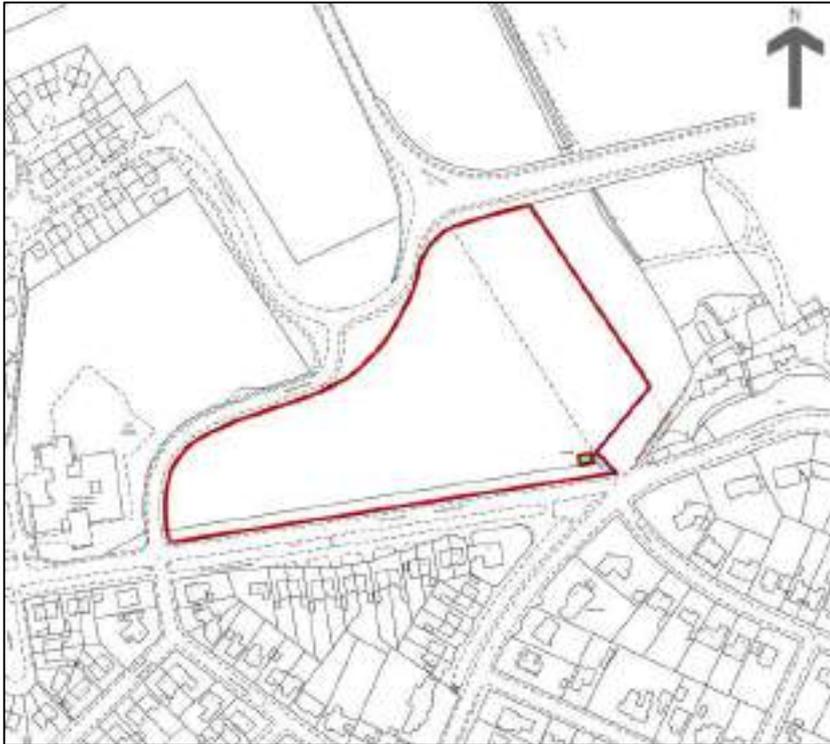
Figure 2: Site location plan.

3.1.1 The site is located off Bodnant Avenue, Prestatyn, Denbighshire (National Grid Reference 307185, 383091). The site location plan is presented as Figure 2 below.

1.1.1 Caulmert Ltd have been appointed by Adra (the client) to undertake a combined Phase I desk study and Phase II geo-environmental appraisal at land adjacent to Bodnant Avenue, Prestatyn, to support a planning application and preliminary scheme design. A site location plan is provided as Figure 2, see over.

3.1.5 The land is traversed north-to-south by a public footpath, as shown by the dotted line on Figure 2.

3.1.6 An electricity substation, located immediately adjacent to this land, is identified in green on Figure 2.

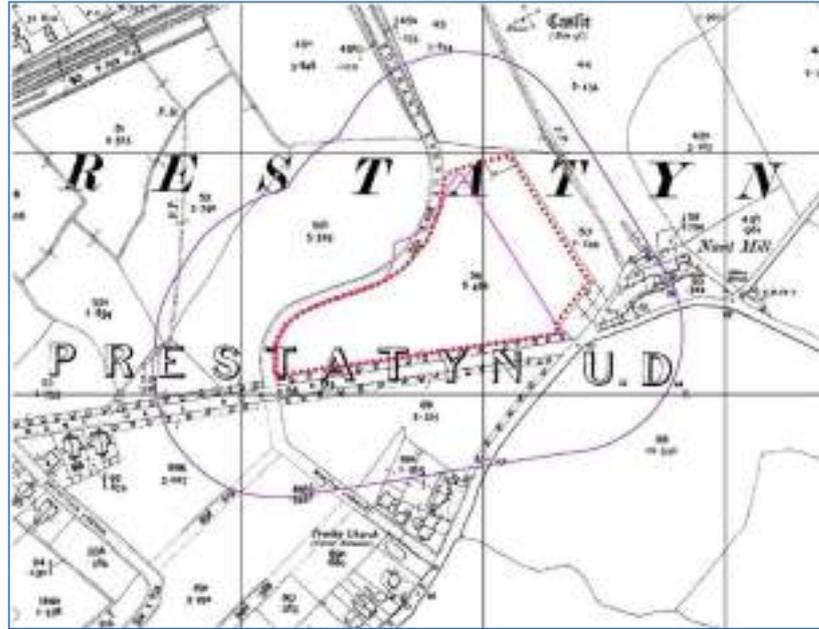
Figure 3B: Historical Map dated 1912 (red line-site boundary).

<p>1914-1915 1:10,560</p>	<p>No significant changes.</p>	<p>No significant changes.</p>
<p>1938 1:10,560</p>	<p>No significant changes.</p>	<p>Further residential housing development to the southwest, south and southeast of the site. Prestatyn Road is now mapped immediately to the north of the site and to the northeast.</p>
<p>1953 1:10,560</p>	<p>No significant changes.</p>	<p>No significant changes.</p>
<p>1962 1:1,250</p>	<p>A footpath is mapped crossing the eastern part of the site from southeast to northwest. An electric substation is shown in the southeastern corner of the site.</p>	<p>Further residential housing development to the southwest, south and southeast of the site. A pond is mapped west/northwest, 100m of the site boundary. The area between Nant Mill and Gronant Road, 30m east of the site, is now labelled as a <i>pond</i>.</p>

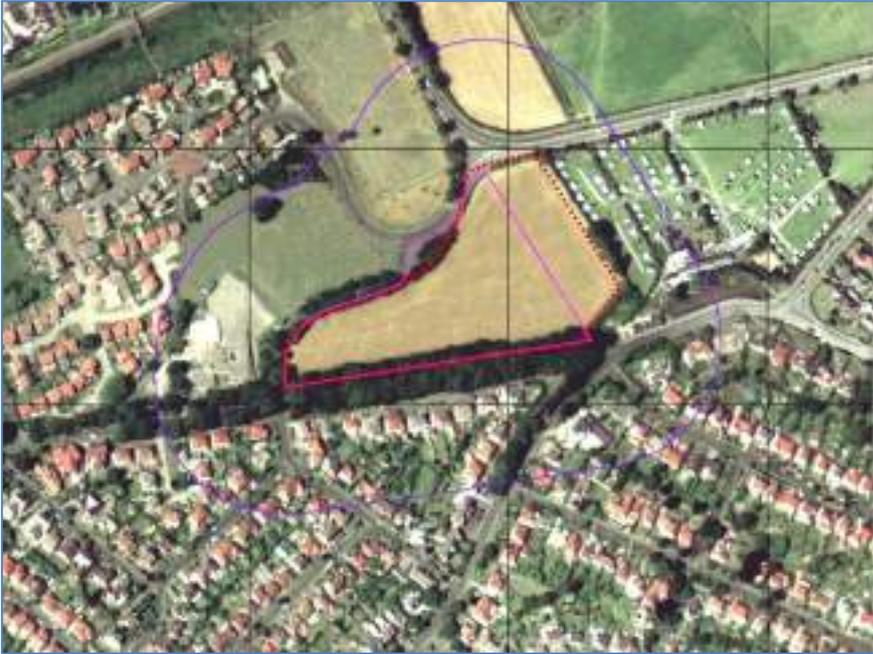
<p>Figure 3D: Historical Aerial Photography 2001 (<i>red line-site boundary</i>).</p>		
<p>2006 1:10,000</p>	<p>No significant changes.</p>	<p>No significant changes.</p>

<p>1993 1:1,250</p>	<p>No significant changes.</p>	<p>The pond mapped west/northwest 100m of the site boundary is no longer shown. The land to the east is named <i>Caravan Site</i>.</p>
<p>2000 1:10,000</p>	<p>No significant changes.</p>	<p>New roads and residential housing 120m northwest of the site. Further housing development east of <i>Nant Mill</i>.</p>
<p>2001 Historical Aerial Photography</p>	<p>No significant changes.</p>	<p>No significant changes.</p>

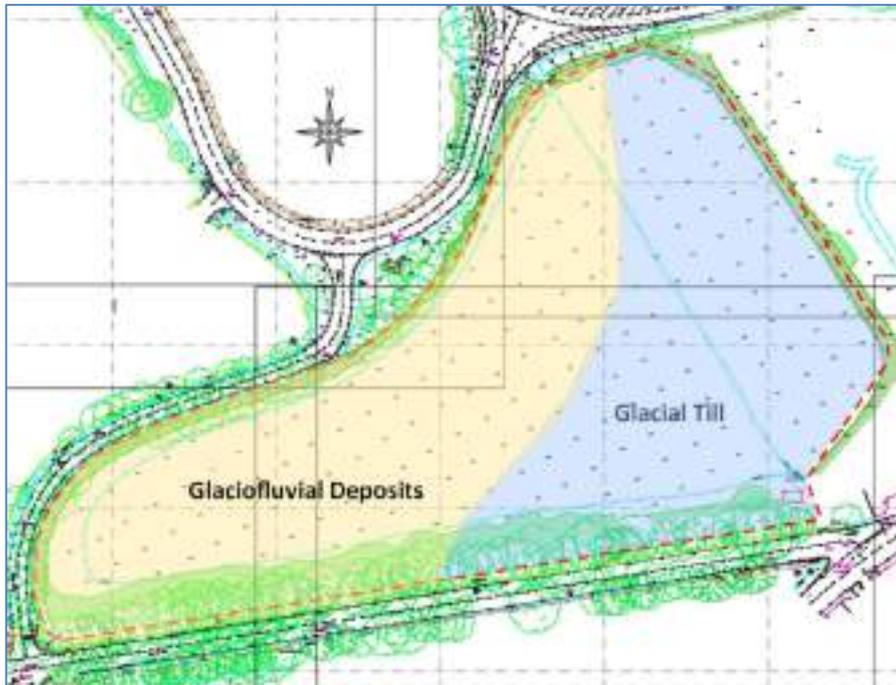
Figure 4: Observed site superficial deposits (red line-site boundary).

8.1.1 The general stratigraphy at the site comprised a veneer of topsoil overlying Glacial Till present in the more elevated area of the site in the east and southeast, and Glaciofluvial Sheet Deposits were present in the west and northwest. Bedrock was not observed during the ground investigation. This generally reflected the published geology; however, the Glaciofluvial Deposits were confirmed to extend a bigger area to the west.

8.4.1 Glaciofluvial Deposits were encountered directly below the topsoil from between 0.2m and 0.3m down to the base of trial pits at 2.4m which is the maximum digging depth of the excavator. The Glaciofluvial Deposits were observed to comprise initially of a layer of dark brown sandy slightly gravelly clay in TP5 (0.2-0.8m), TP7 (0.3-0.5m), TP8 (0.2-0.5m) and sandy to very sandy slightly gravelly clay in SA1 (0.2-0.4m) and in SA2 (0.2-0.3m). This initial cohesive layer is underlain by alternating layers of sandy to very sandy, locally slightly clayey to clayey, gravel, slightly gravelly to gravelly sand, locally very clayey, as well as occasional lenses or layers of clay. The abovementioned proves the variable nature of Glaciofluvial Deposits. Gravel is fine to coarse subrounded limestone, mudstone and sandstone.

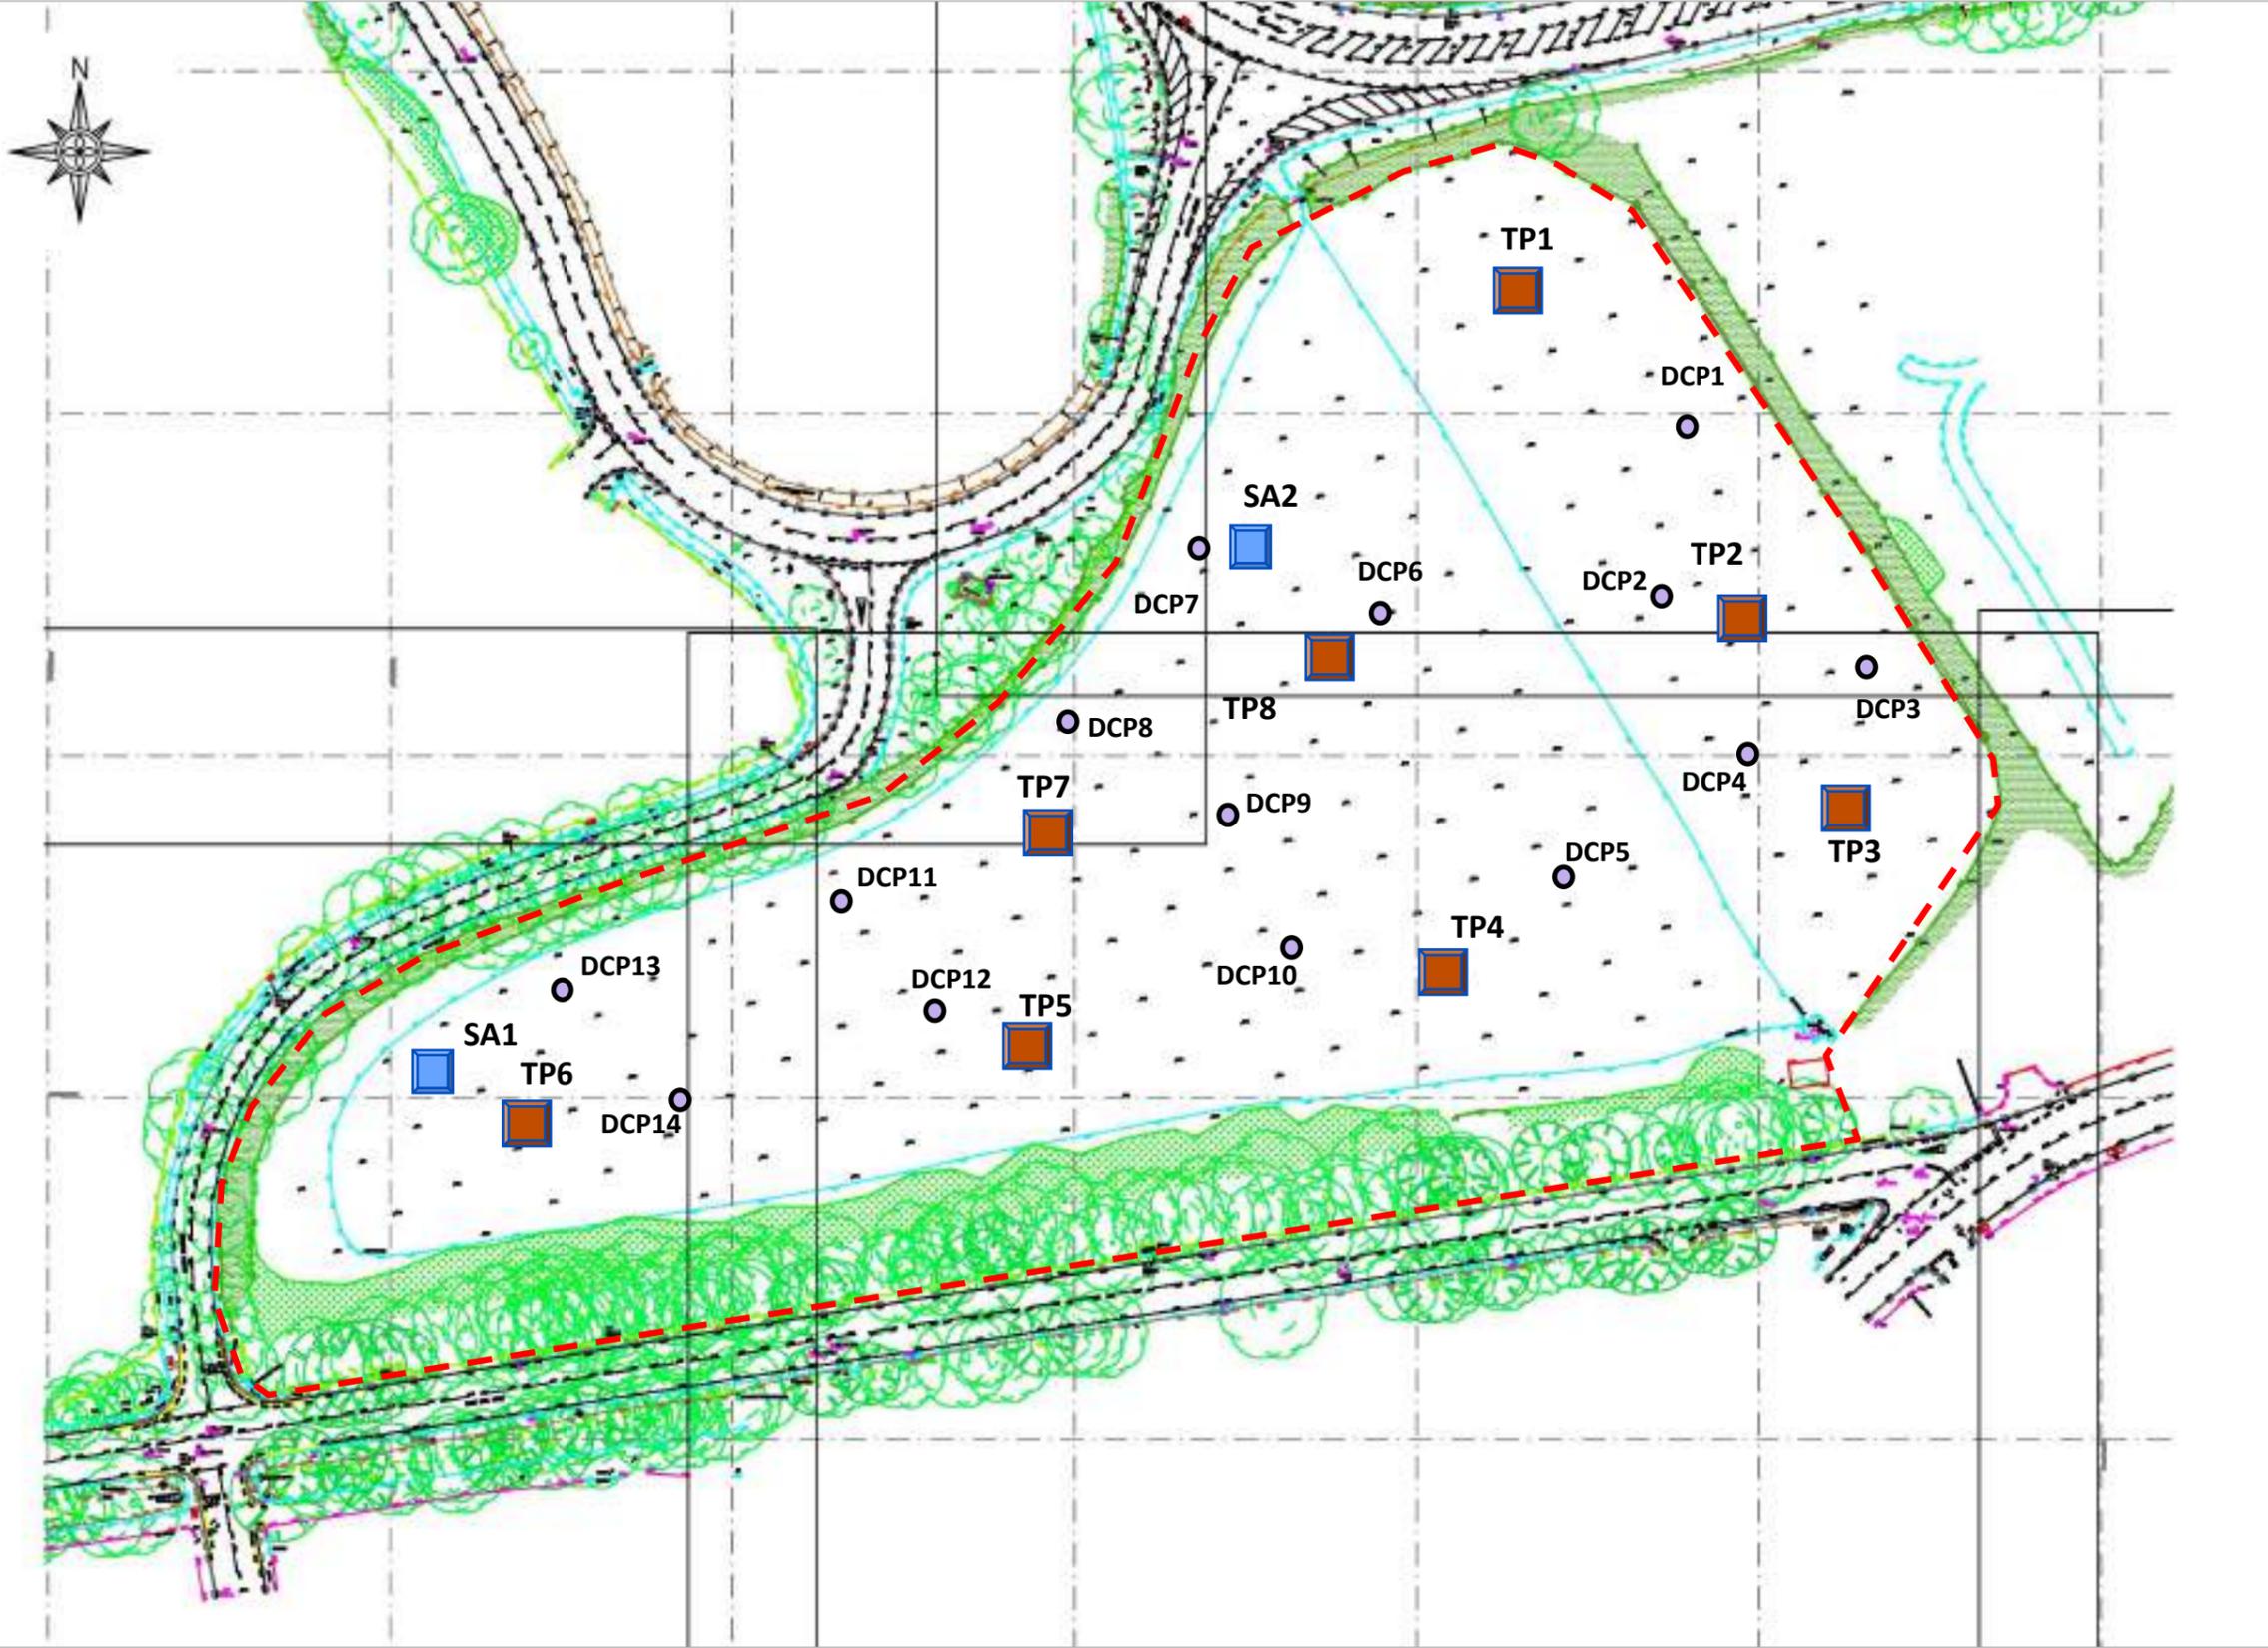
Drawing: Ground Investigation Location Plan
Job no: 5986
Project: Bodnant Avenue
Site: Bodnant Avenue, Prestatyn
Client: ADRA
Date: 18.09.2024

- TP1 - machine excavated trial pit
- SA1 - permeability test
- DCP1 - dynamic cone penetration test
- Site boundary

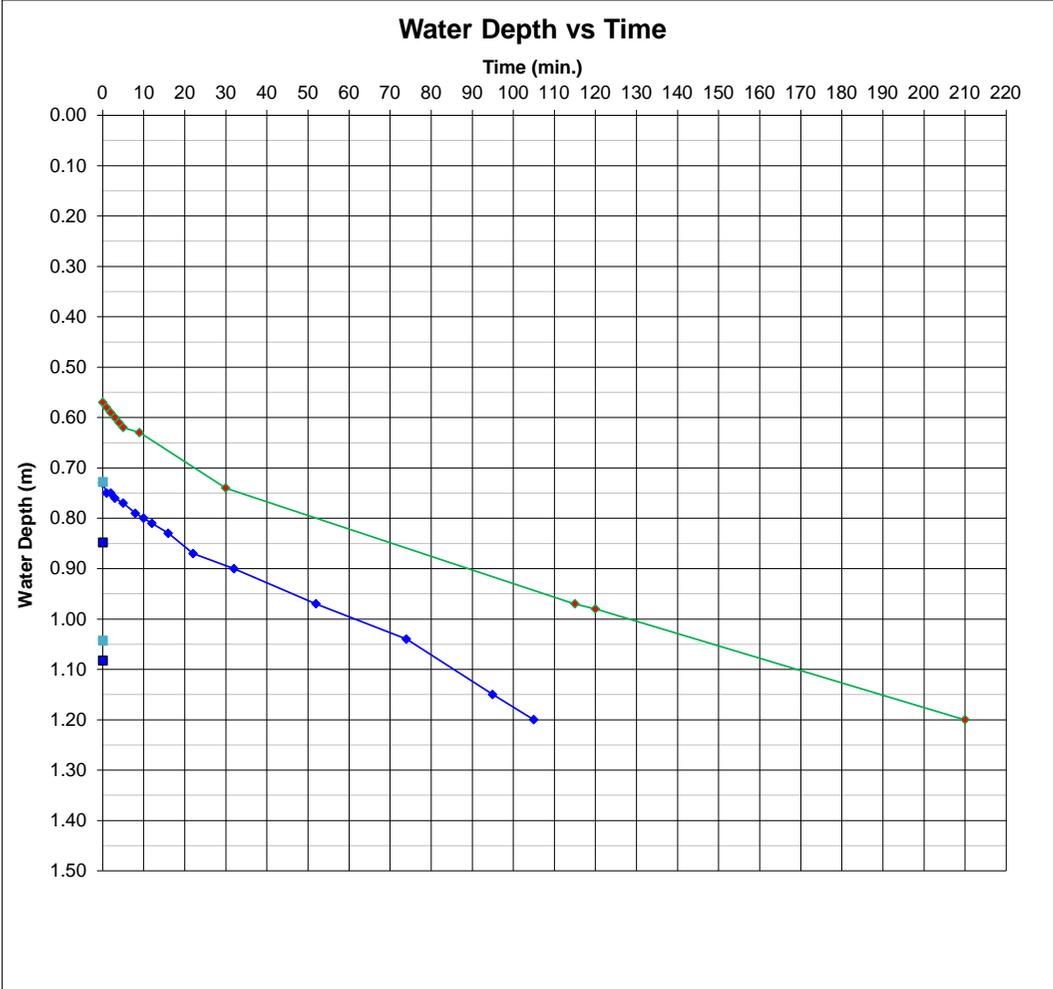
Over 75% - 25% effective depth	2.5E-05	2.4E-05

Design Soil Infiltration Rate: 2.4×10^{-5} m/s

Location	Depth (mbgl)	Infiltration Cycle 1 (m/s)	Infiltration Cycle 2 (m/s)	Design Infiltration Rate (m/s)	Comments
SA1	1.20	2.5×10^{-5}	2.4×10^{-5}	2.4×10^{-5}	Good drainage
SA2	1.50	1.0×10^{-5}	1.3×10^{-5}	1.0×10^{-5}	Good drainage

8.6.4 The infiltration rates in SA1 and SA2 indicate good infiltration materials with the calculated infiltration design rates of 2.4×10^{-5} m/s and 1.0×10^{-5} m/s respectively.

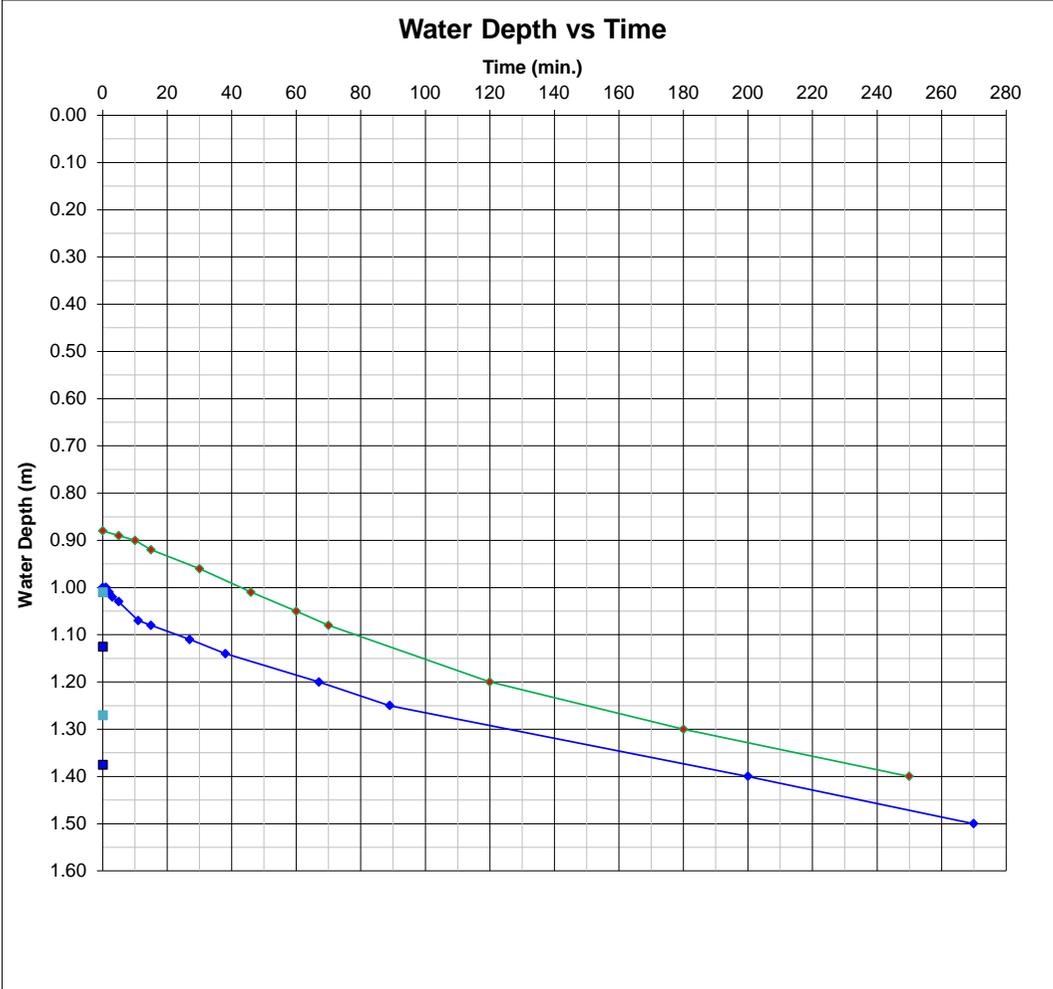
Over measured depth	6.9E-06	7.5E-06	
Over 75% - 25% effective depth	1.0E-05	1.3E-05

Design Soil Infiltration Rate: 1×10^{-5} m/s

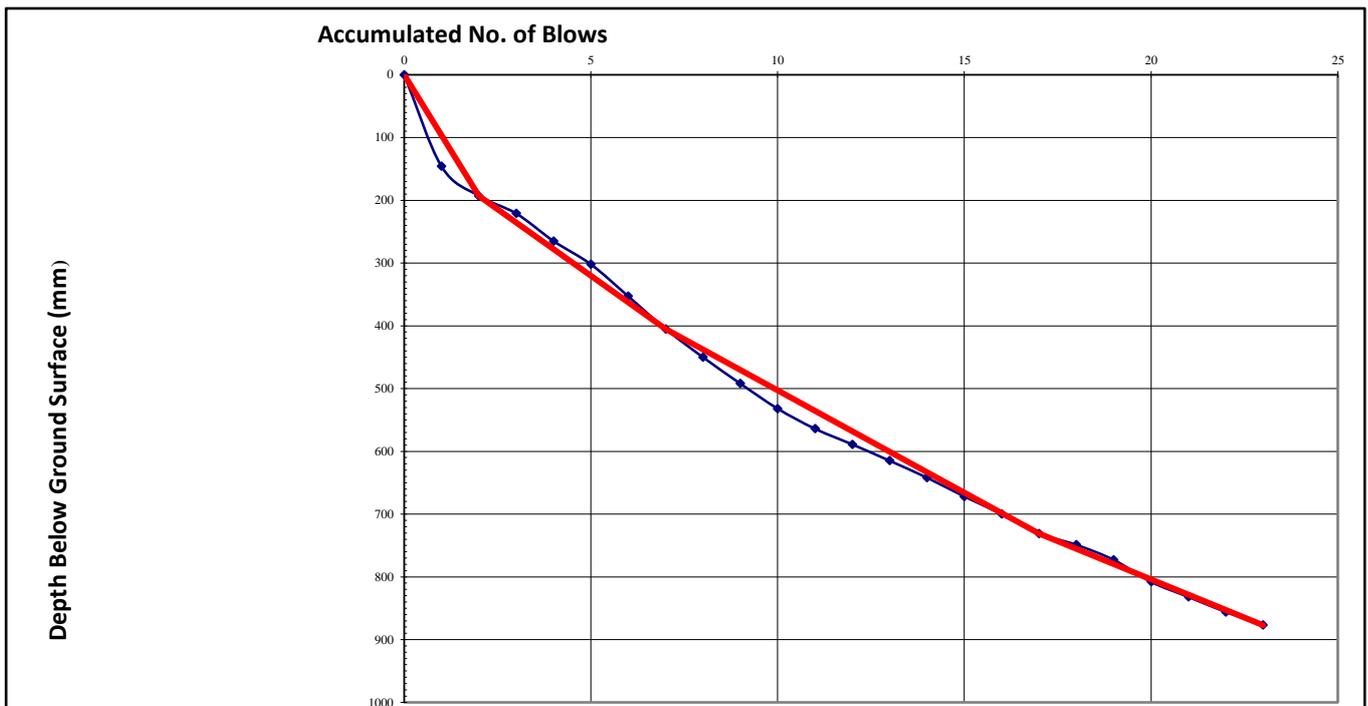
Site:	Ffordd Parc Bodnant, Prestatyn	Test Location:	1
Material Description:	Existing sub-soil	GPS co-ordinates	N/A
DCP Reference:	7258B	Date Tested:	10/10/2024
		Tested By:	DAT/JSW

Layer	1	2	3	4	5	6	7
Start depth of layer (mm)	0	193	405	731			
Finish depth of layer (mm)	193	405	731	877			
Layer depth (mm)	193	212	326	146	0	0	0
Blow per layer (No)	2	5	10	6	0	0	0
DCP (mm/blow)	96.5	42.4	32.6	24.3			
CBR (%)	2.4	5.8	7.6	10.3			
Surface Modulus (Mpa)	30.9	53.9	64.4	78.5

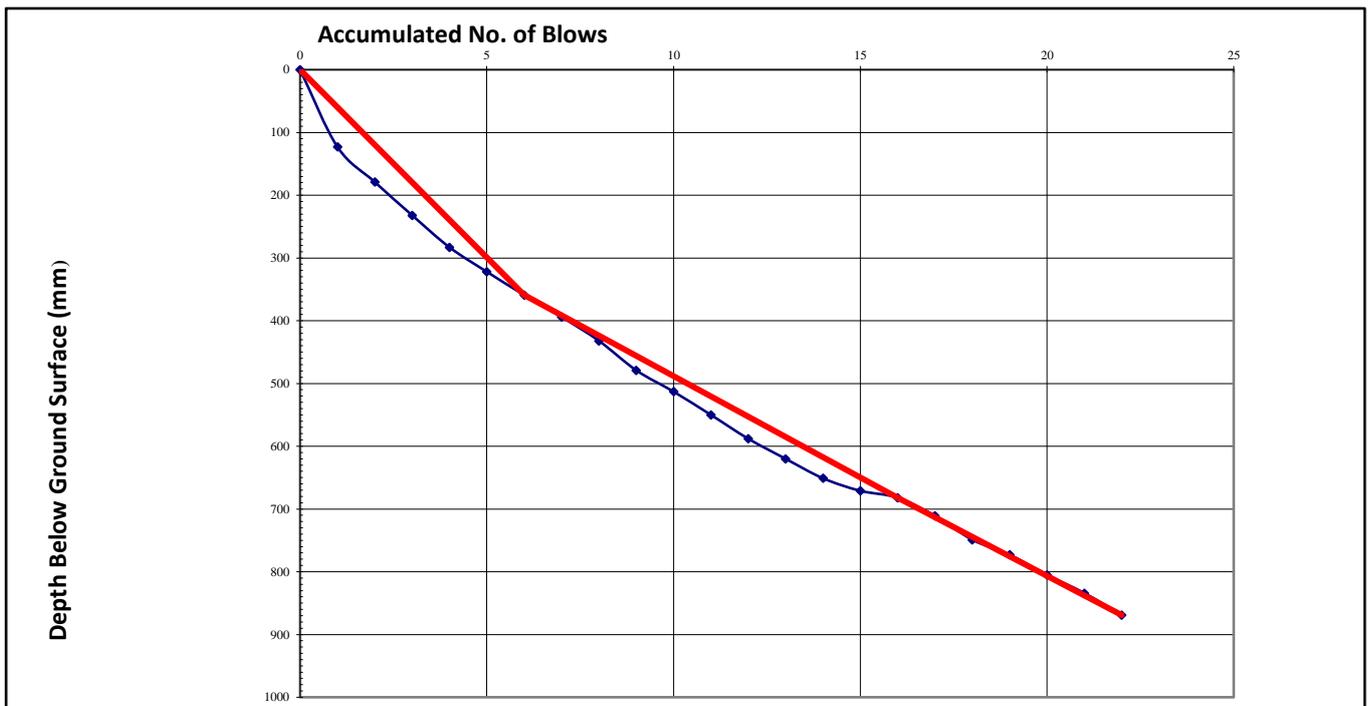
Site:	Ffordd Parc Bodnant, Prestatyn	Test Location:	2
Material Description:	Existing sub-soil	GPS co-ordinates:	N/A
DCP Reference:	7258B	Date Tested:	10/10/2024
		Tested By:	DAT/JSW

Layer	1	2	3	4	5	6	7
Start depth of layer (mm)	0	359	682				
Finish depth of layer (mm)	359	682	869				
Layer depth (mm)	359	323	187	0	0	0	0
Blow per layer (No)	6	10	6	0	0	0	0
DCP (mm/blow)	59.8	32.3	31.2				
CBR (%)	4.0	7.7	8.0				
Surface Modulus (Mpa)	42.7	64.8	66.4

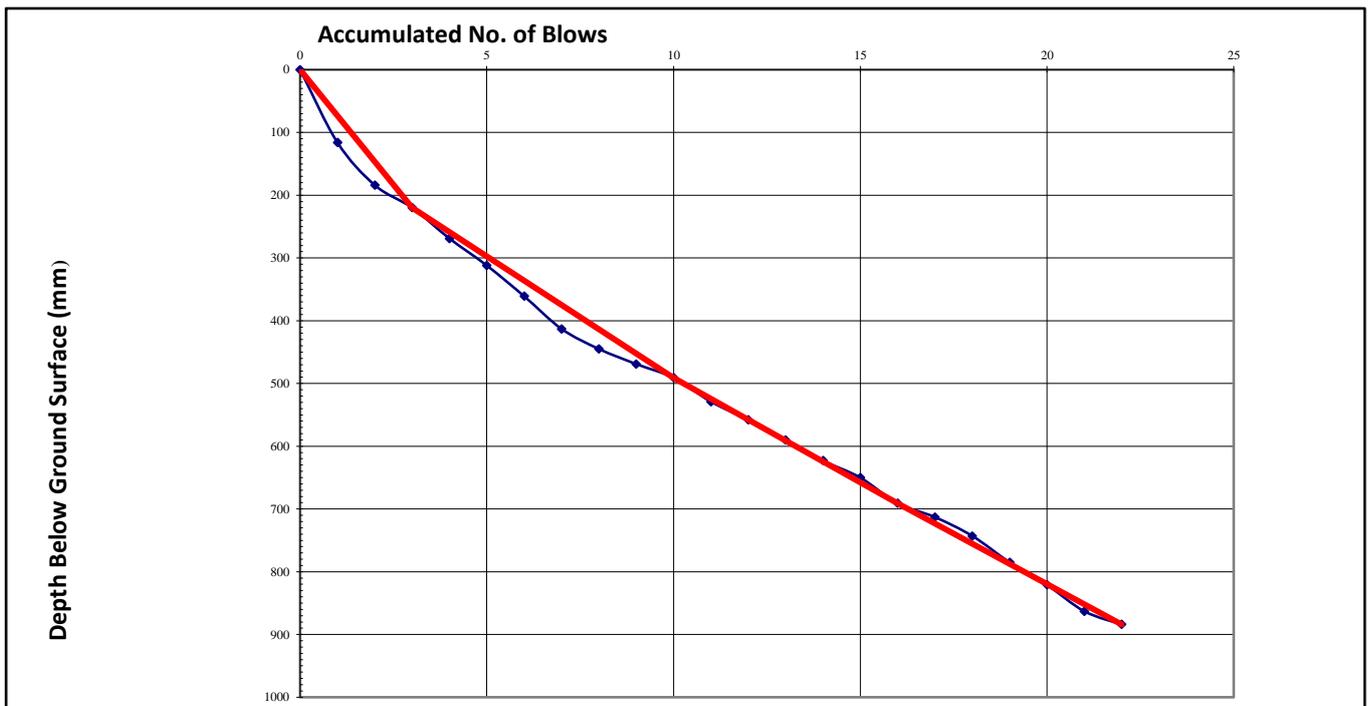
Site:	Ffordd Parc Bodnant, Prestatyn	Test Location:	3
Material Description:	Existing sub-soil	GPS co-ordinates:	N/A
DCP Reference:	7258B	Date Tested:	10/10/2024
		Tested By:	DAT/JSW

Layer	1	2	3	4	5	6	7
Start depth of layer (mm)	0	220	491	691			
Finish depth of layer (mm)	220	491	691	884			
Layer depth (mm)	220	271	200	193	0	0	0
Blow per layer (No)	3	7	6	6	0	0	0
DCP (mm/blow)	73.3	38.7	33.3	32.2			
CBR (%)	3.2	6.3	7.4	7.7			
Surface Modulus (Mpa)	37.2	57.4	63.5	65.0

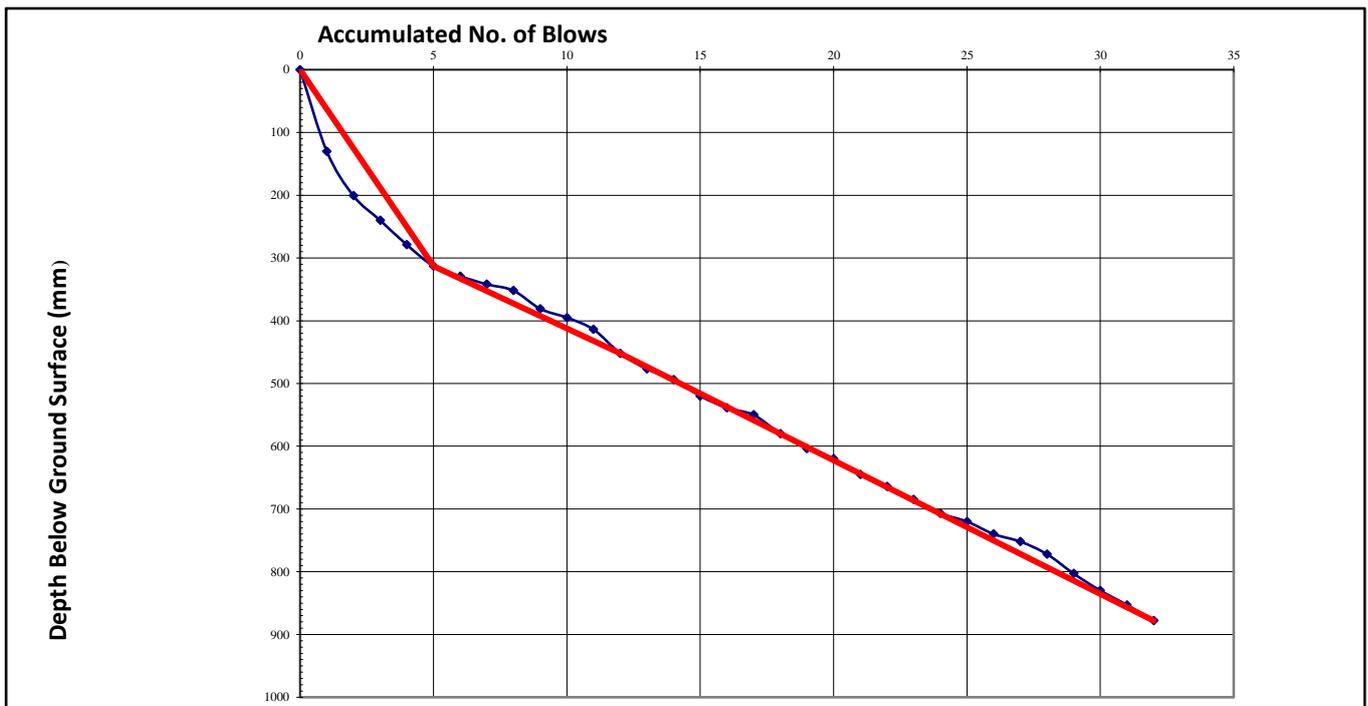
Site:	Ffordd Parc Bodnant, Prestatyn	Test Location:	4
Material Description:	Existing sub-soil	GPS co-ordinates:	N/A
DCP Reference:	7258B	Date Tested:	10/10/2024
		Tested By:	DAT/JSW

Layer	1	2	3	4	5	6	7
Start depth of layer (mm)	0	313	452	580			
Finish depth of layer (mm)	313	452	580	878			
Layer depth (mm)	313	139	128	298	0	0	0
Blow per layer (No)	5	7	6	14	0	0	0
DCP (mm/blow)	62.6	19.9	21.3	21.3			
CBR (%)	3.8	12.8	11.9	11.9			
Surface Modulus (Mpa)	41.4	90.1	85.8	86.0

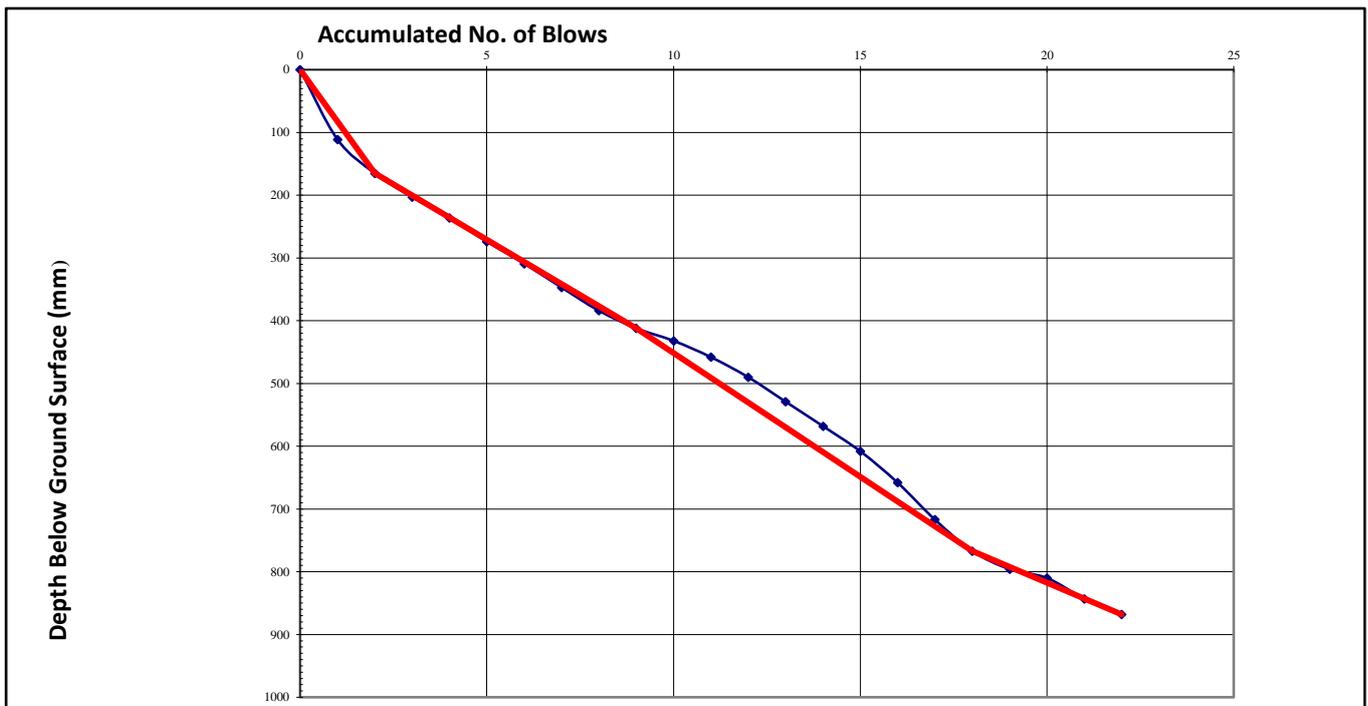
Site:	Ffordd Parc Bodnant, Prestatyn	Test Location:	5
Material Description:	Existing sub-soil	GPS co-ordinates:	N/A
DCP Reference:	7258B	Date Tested:	10/10/2024
		Tested By:	DAT/JSW

Layer	1	2	3	4	5	6	7
Start depth of layer (mm)	0	165	412	767			
Finish depth of layer (mm)	165	412	767	868			
Layer depth (mm)	165	247	355	101	0	0	0
Blow per layer (No)	2	7	9	4	0	0	0
DCP (mm/blow)	82.5	35.3	39.4	25.3			
CBR (%)	2.8	7.0	6.2	9.9			
Surface Modulus (Mpa)	34.4	61.1	56.6	76.6

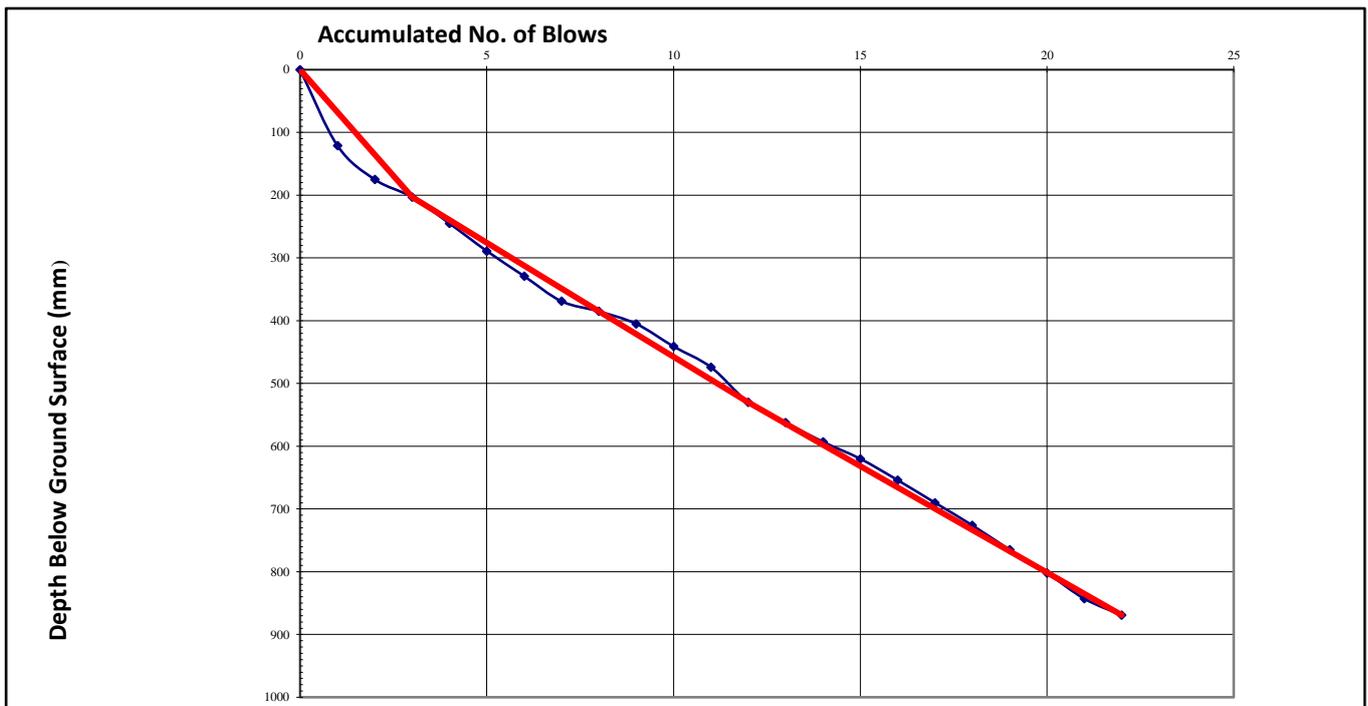
Site:	Ffordd Parc Bodnant, Prestatyn	Test Location:	6
Material Description:	Existing sub-soil	GPS co-ordinates:	N/A
DCP Reference:	7258B	Date Tested:	10/10/2024
		Tested By:	DAT/JSW

Layer	1	2	3	4	5	6	7
Start depth of layer (mm)	0	203	385	530			
Finish depth of layer (mm)	203	385	530	869			
Layer depth (mm)	203	182	145	339	0	0	0
Blow per layer (No)	3	5	4	10	0	0	0
DCP (mm/blow)	67.7	36.4	36.3	33.9			
CBR (%)	3.5	6.8	6.8	7.3			
Surface Modulus (Mpa)	39.3	59.8	60.0	62.7

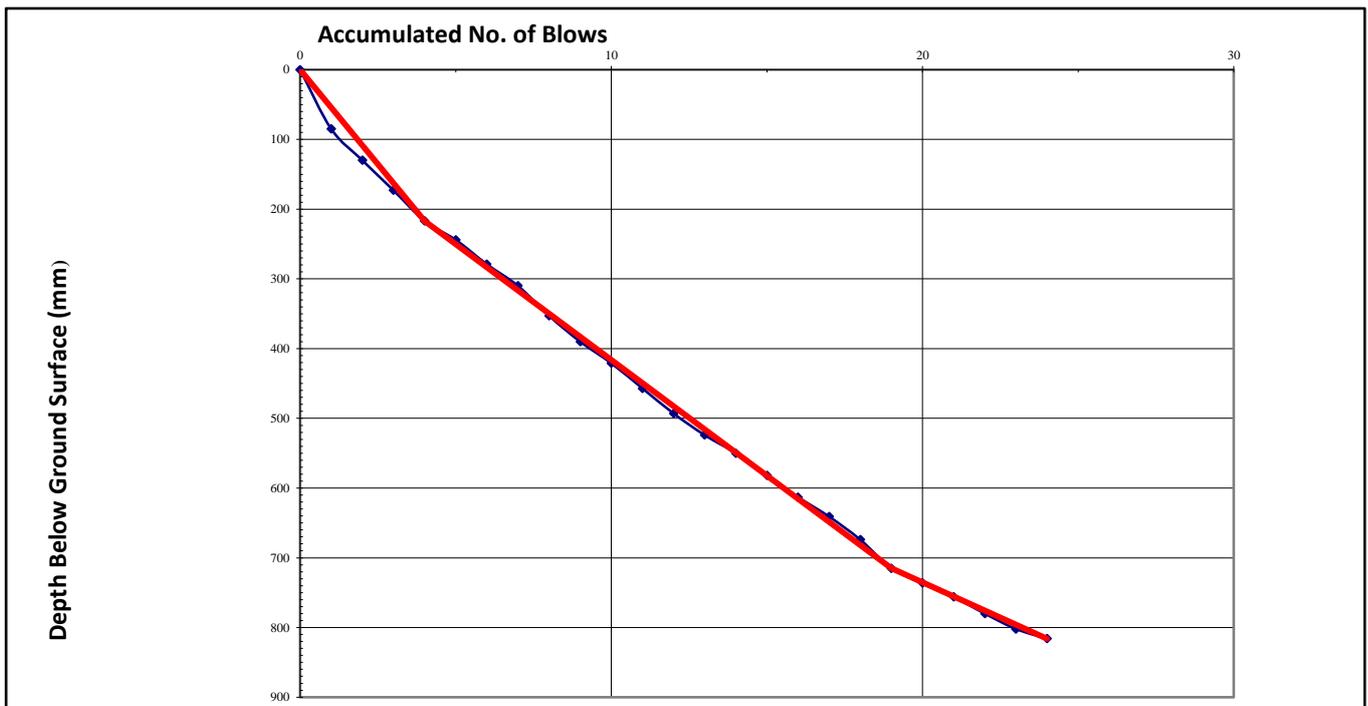
Site:	Ffordd Parc Bodnant, Prestatyn	Test Location:	7
Material Description:	Existing sub-soil	GPS co-ordinates:	N/A
DCP Reference:	7258B	Date Tested:	10/10/2024
		Tested By:	DAT/JSW

Layer	1	2	3	4	5	6	7
Start depth of layer (mm)	0	217	715				
Finish depth of layer (mm)	217	715	816				
Layer depth (mm)	217	498	101	0	0	0	0
Blow per layer (No)	4	15	5	0	0	0	0
DCP (mm/blow)	54.3	33.2	20.2				
CBR (%)	4.4	7.5	12.6				
Surface Modulus (Mpa)	45.6	63.6	89.1

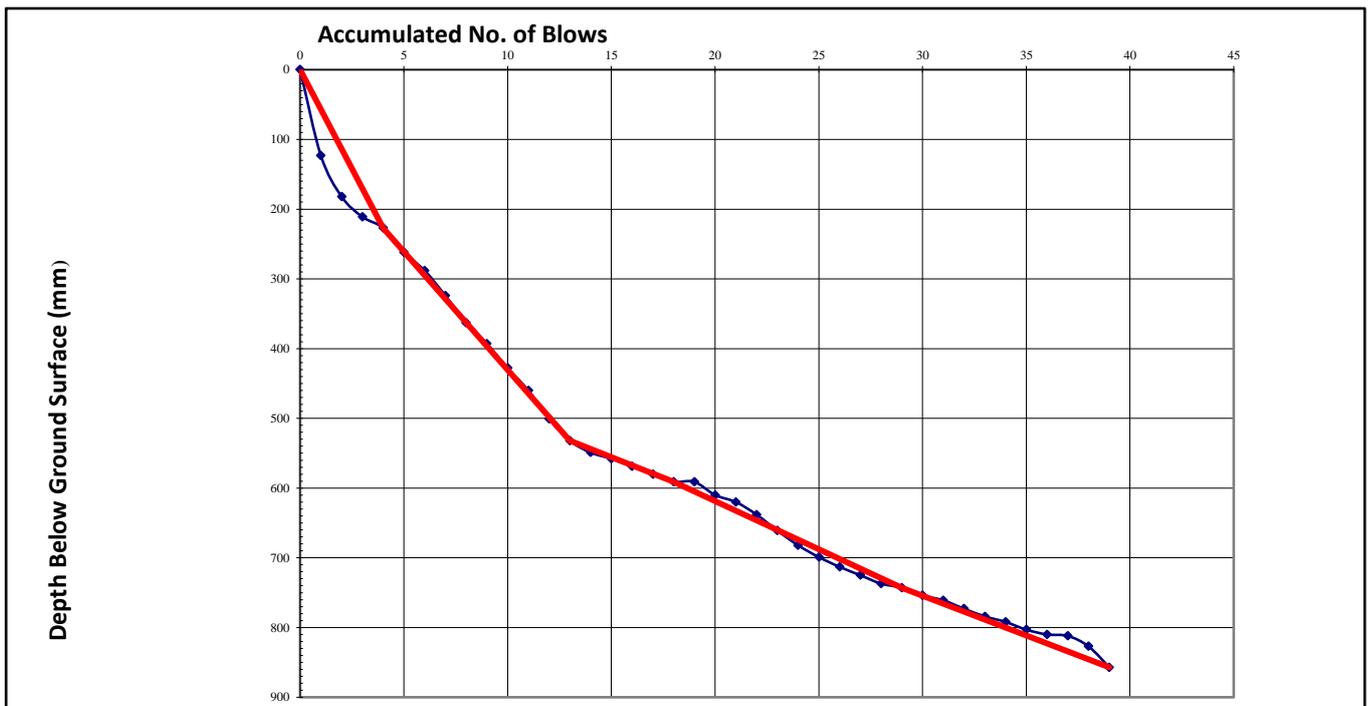
Site:	Ffordd Parc Bodnant, Prestatyn	Test Location:	8
Material Description:	Existing sub-soil	GPS co-ordinates:	N/A
DCP Reference:	7258B	Date Tested:	10/10/2024
		Tested By:	DAT/JSW

Layer	1	2	3	4	5	6	7
Start depth of layer (mm)	0	227	532	591	743		
Finish depth of layer (mm)	227	532	591	743	857		
Layer depth (mm)	227	305	59	152	114	0	0
Blow per layer (No)	4	9	5	11	10	0	0
DCP (mm/blow)	56.8	33.9	11.8	13.8	11.4		
CBR (%)	4.2	7.3	22.2	18.8	23.1		
Surface Modulus (Mpa)	44.3	62.8	128.1	115.1	131.1

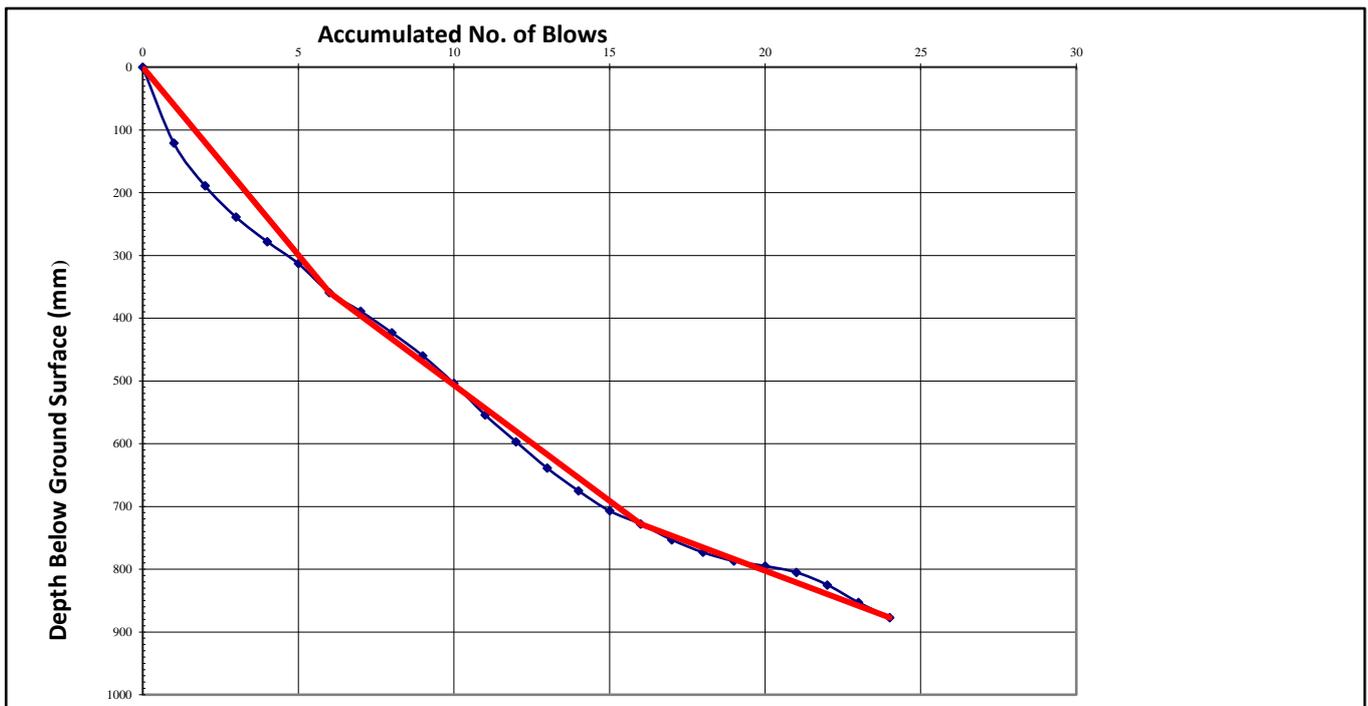
Site:	Ffordd Parc Bodnant, Prestatyn	Test Location:	9
Material Description:	Existing sub-soil	GPS co-ordinates:	N/A
DCP Reference:	7258B	Date Tested:	10/10/2024
		Tested By:	DAT/JSW

Layer	1	2	3	4	5	6	7
Start depth of layer (mm)	0	359	728				
Finish depth of layer (mm)	359	728	877				
Layer depth (mm)	359	369	149	0	0	0	0
Blow per layer (No)	6	10	8	0	0	0	0
DCP (mm/blow)	59.8	36.9	18.6				
CBR (%)	4.0	6.7	13.7				
Surface Modulus (Mpa)	42.7	59.2	94.1

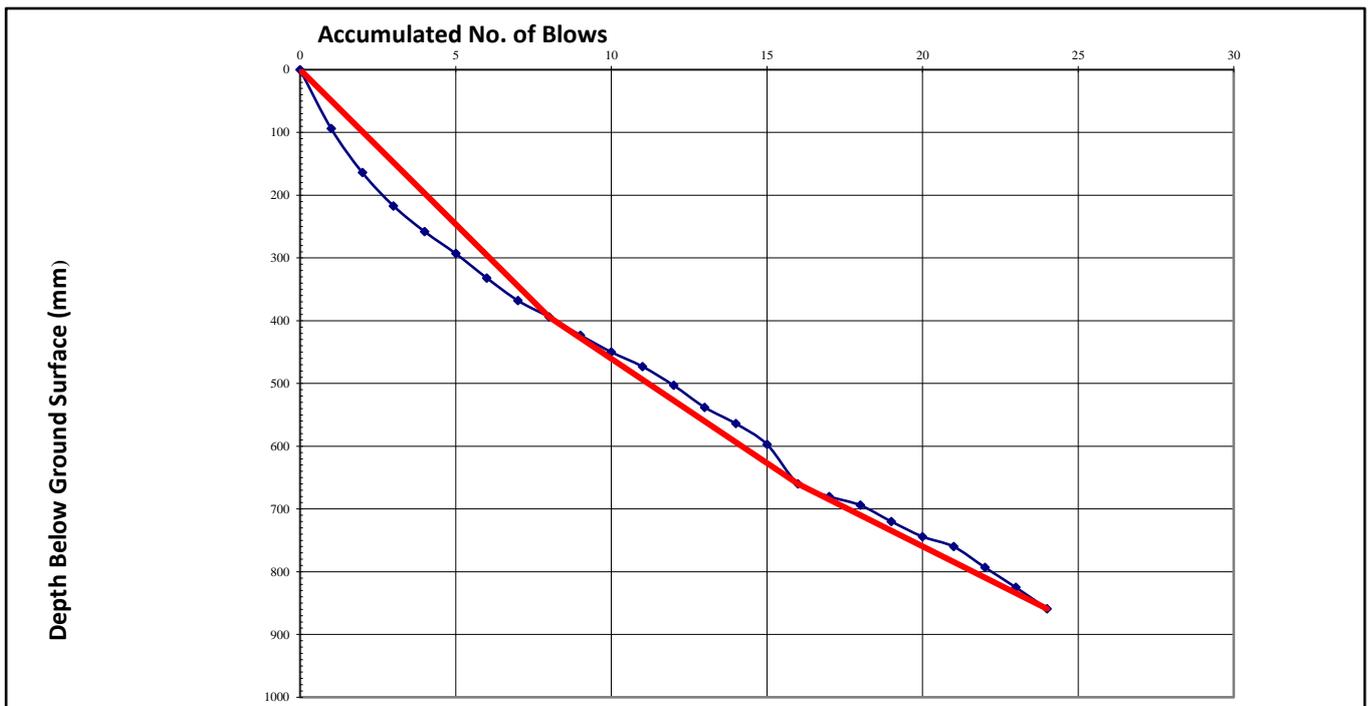
Site:	Ffordd Parc Bodnant, Prestatyn	Test Location:	10
Material Description:	Existing sub-soil	GPS co-ordinates:	N/A
DCP Reference:	7258B	Date Tested:	10/10/2024
		Tested By:	DAT/JSW

Layer	1	2	3	4	5	6	7
Start depth of layer (mm)	0	394	660				
Finish depth of layer (mm)	394	660	859				
Layer depth (mm)	394	266	199	0	0	0	0
Blow per layer (No)	8	8	8	0	0	0	0
DCP (mm/blow)	49.3	33.3	24.9				
CBR (%)	4.9	7.4	10.1				
Surface Modulus (Mpa)	48.7	63.6	77.4

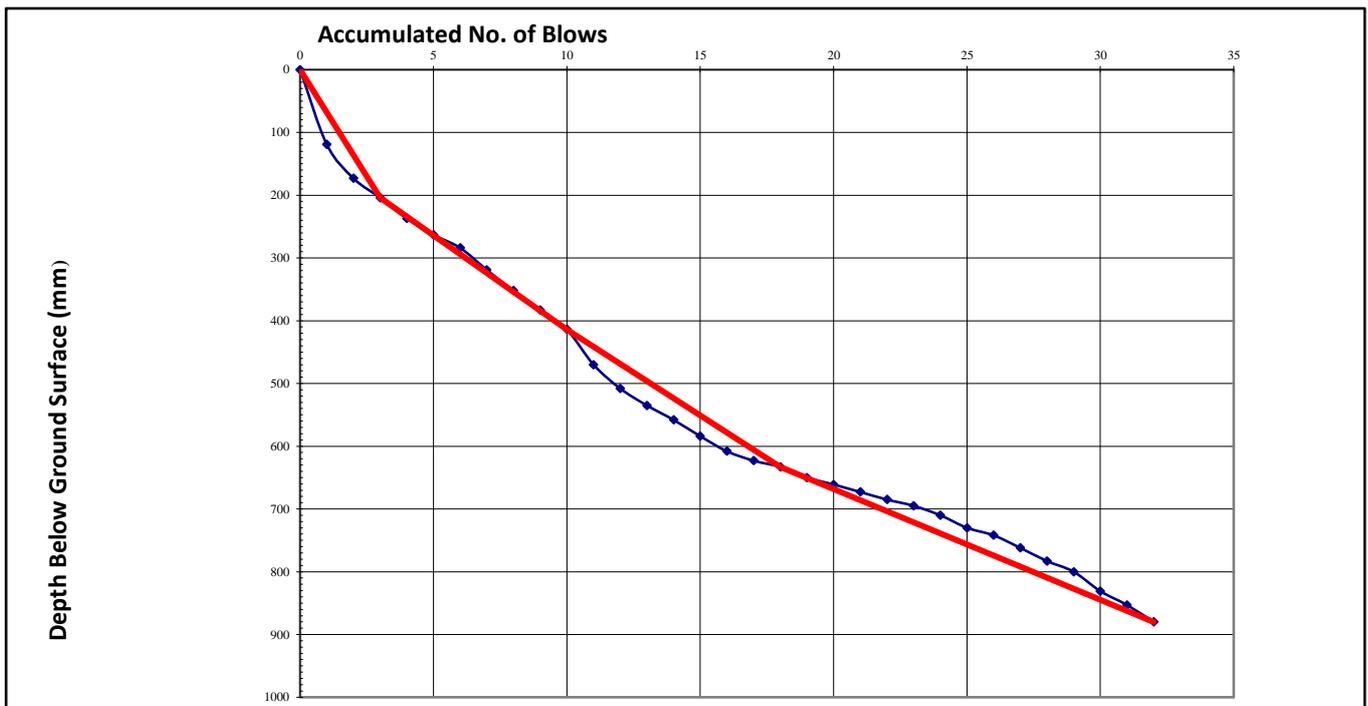
Test Results
Test 11

Site:	Ffordd Parc Bodnant, Prestatyn	Test Location:	11
Material Description:	Existing sub-soil	GPS co-ordinates:	N/A
DCP Reference:	7258B	Date Tested:	10/10/2024
		Tested By:	DAT/JSW

Layer	1	2	3	4	5	6	7
Start depth of layer (mm)	0	204	414	633			
Finish depth of layer (mm)	204	414	633	880			
Layer depth (mm)	204	210	219	247	0	0	0
Blow per layer (No)	3	7	8	14	0	0	0
DCP (mm/blow)	68.0	30.0	27.4	17.6			
CBR (%)	3.5	8.3	9.1	14.5			
Surface Modulus (Mpa)	39.2	68.2	72.5	97.6
