Bodnant Avenue Housing Site

Phase I and Phase II Geo-Environmental Report

Document Reference: 5986-CAU-XX-XX-RP-V-3001

October 2024

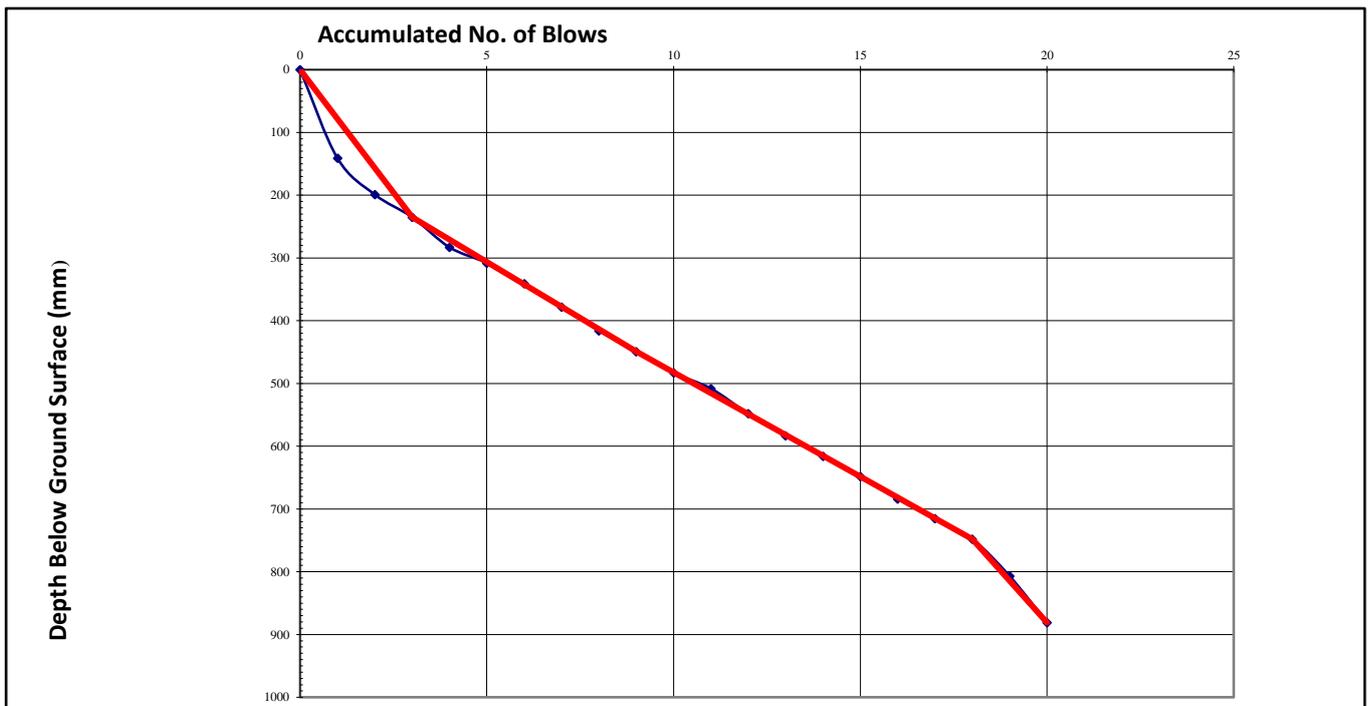
Test Results
Test 12

Site:	Ffordd Parc Bodnant, Prestatyn	Test Location:	12
Material Description:	Existing sub-soil	GPS co-ordinates:	N/A
DCP Reference:	7258B	Date Tested:	10/10/2024
		Tested By:	DAT/JSW

Layer	1	2	3	4	5	6	7
Start depth of layer (mm)	0	235	449	748			
Finish depth of layer (mm)	235	449	748	881			
Layer depth (mm)	235	214	299	133	0	0	0
Blow per layer (No)	3	6	9	2	0	0	0
DCP (mm/blow)	78.3	35.7	33.2	66.5			
CBR (%)	3.0	6.9	7.4	3.6			
Surface Modulus (Mpa)	35.6	60.6	63.6	39.8

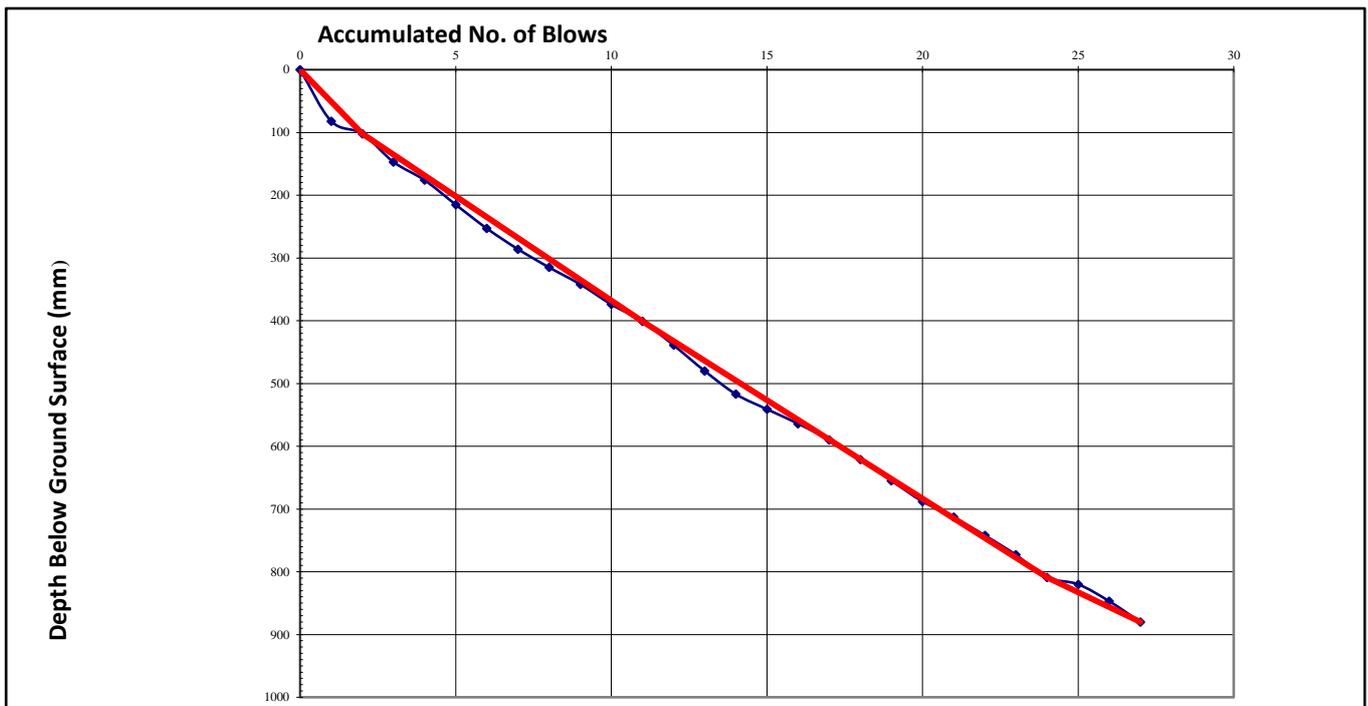
Test Results
Test 13

Site:	Ffordd Parc Bodnant, Prestatyn	Test Location:	13
Material Description:	Existing sub-soil	GPS co-ordinates:	N/A
DCP Reference:	7258B	Date Tested:	10/10/2024
		Tested By:	DAT/JSW

Layer	1	2	3	4	5	6	7
Start depth of layer (mm)	0	102	401	809			
Finish depth of layer (mm)	102	401	809	880			
Layer depth (mm)	102	299	408	71	0	0	0
Blow per layer (No)	2	9	13	3	0	0	0
DCP (mm/blow)	51.0	33.2	31.4	23.7			
CBR (%)	4.7	7.4	7.9	10.7			
Surface Modulus (Mpa)	47.6	63.6	66.1	80.0

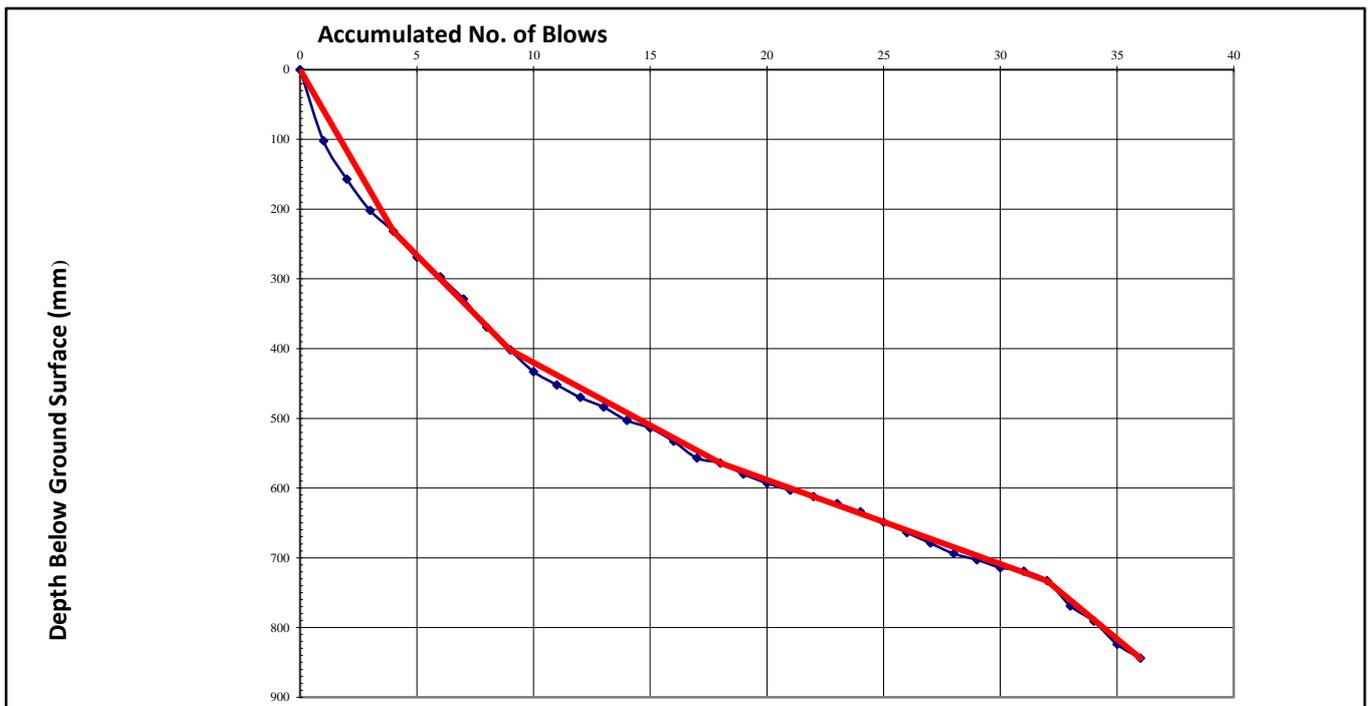
Test Results
Test 14

Site:	Ffordd Parc Bodnant, Prestatyn	Test Location:	14
Material Description:	Existing sub-soil	GPS co-ordinates:	N/A
DCP Reference:	7258B	Date Tested:	10/10/2024
		Tested By:	DAT/JSW

Layer	1	2	3	4	5	6	7
Start depth of layer (mm)	0	232	402	564	733		
Finish depth of layer (mm)	232	402	564	733	844		
Layer depth (mm)	232	170	162	169	111	0	0
Blow per layer (No)	4	5	9	14	4	0	0
DCP (mm/blow)	58.0	34.0	18.0	12.1	27.8		
CBR (%)	4.1	7.3	14.2	21.7	9.0		
Surface Modulus (Mpa)	43.6	62.6	96.3	126.2	71.8

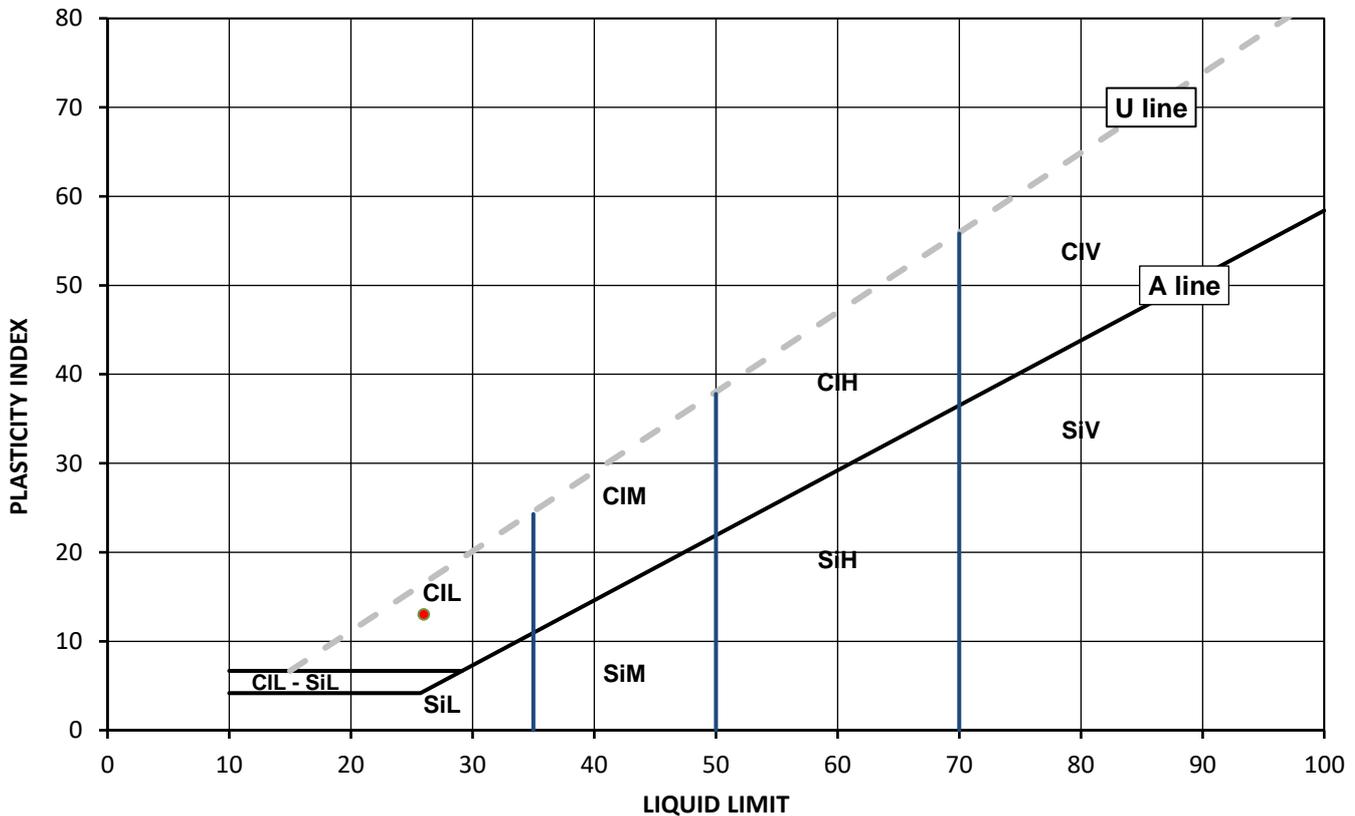
As Received Water Content [W] %	Corrected Liquid Limit [WL] %	Correlation Factor	Plastic Limit [Wp] %	Plasticity Index [Ip] %	Liquidity index [IL] % #	Consistency index [IC] % #	% Passing 425µm BS Test Sieve
11.7	26	1.015	13	13	-0.08	1.08	76

8.3.3 Atterberg Limit tests on two abovementioned samples recorded a moisture content of 9.8% and 11.7%, and a Modified Plasticity Index value of 10%. This would correspond to soils with a low volume change potential. However, the samples are classified as SC soils; very clayey gravelly sand with the percentage of 26% and 32%. Taking into account all of the above the soils can be considered as non-plastic.

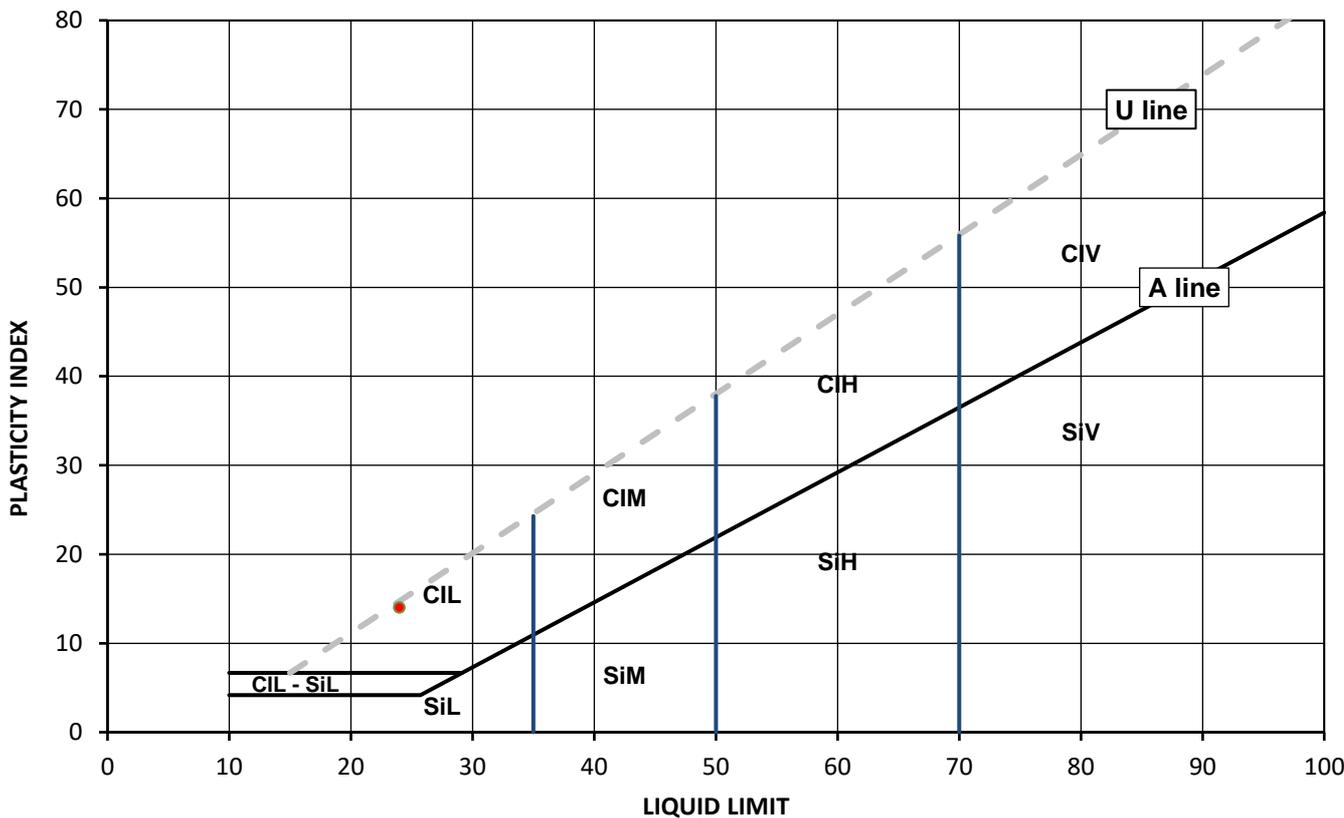
As Received Water Content [W] %	Corrected Liquid Limit [WL] %	Correlation Factor	Plastic Limit [Wp] %	Plasticity Index [Ip] %	Liquidity index [IL] % #	Consistency index [IC] % #	% Passing 425µm BS Test Sieve
9.8	24	1.030	10	14	0.00	1.00	73

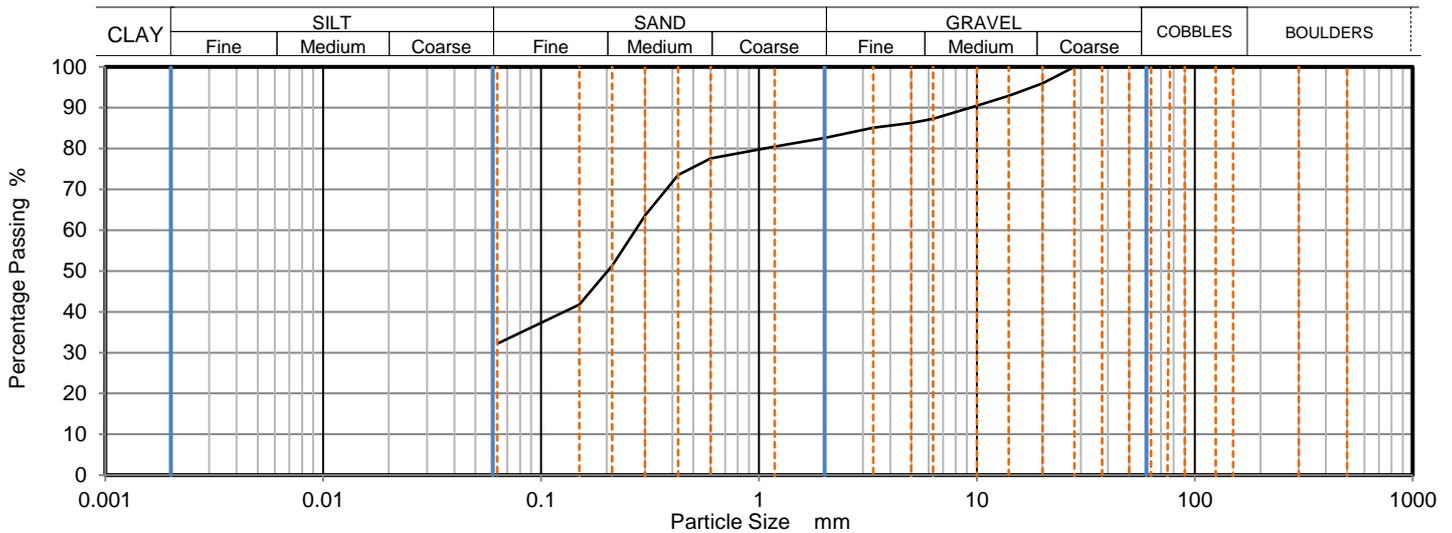
Depth Top [m]: 1.10
Depth Base [m]: Not Given
Sample Type: B

Sieving		Sedimentation	
Particle Size mm	% Passing	Particle Size mm	% Passing
500	100		
300	100		
150	100		
125	100		
90	100		
75	100		
63	100		
50	100		
37.5	100		
28	100		
20	96		
14	93		
10	91		
6.3	87		
5	86		
3.35	85		
2	83		
1.18	81		
0.6	78		
0.425	74		
0.3	64		
0.212	51		
0.15	42		
0.063	32

- 8.4.2 Three samples were tested for Particle Size Distribution and the results indicate very clayey gravelly sand with 34% of fines in one sample, and clayey very sandy gravel with 9% and 11% of fines in another two samples.
- 8.4.3 According to Unified Soil Classification System (USCS) the soils can be classified as SC; poorly graded very clayey gravelly sand, and GP-GC poorly graded clayey very sandy gravel.

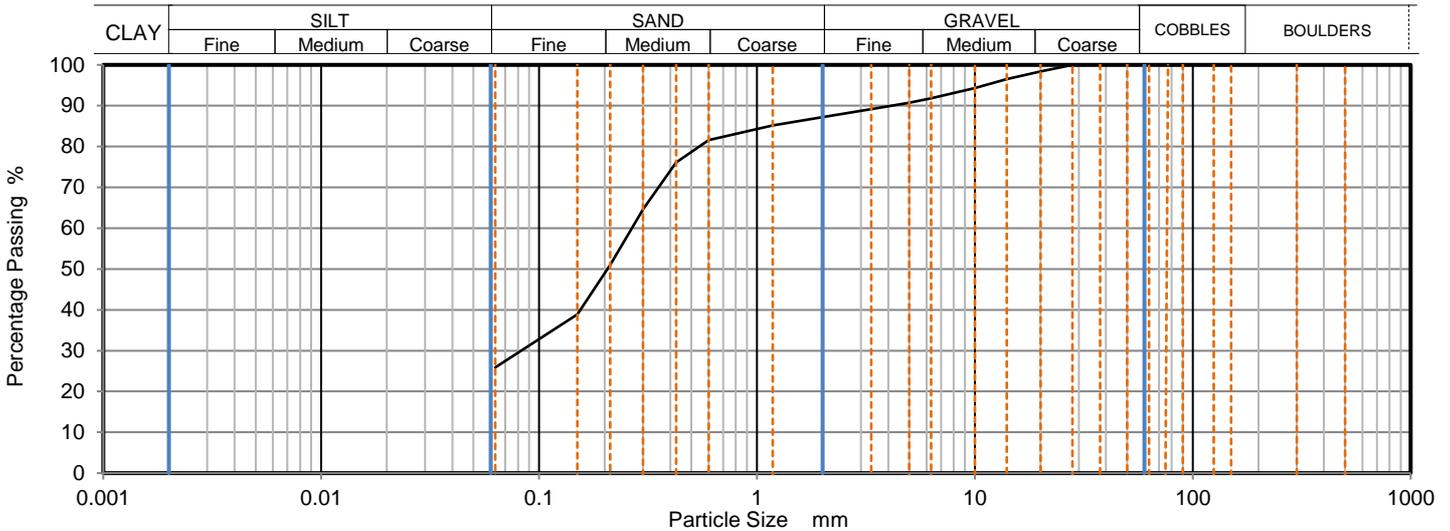
Depth Top [m]: 1.40
Depth Base [m]: Not Given
Sample Type: B

Sieving		Sedimentation	
Particle Size mm	% Passing	Particle Size mm	% Passing
500	100		
300	100		
150	100		
125	100		
90	100		
75	100		
63	100		
50	100		
37.5	100		
28	100		
20	98		
14	97		
10	94		
6.3	92		
5	91		
3.35	89		
2	87		
1.18	85		
0.6	82		
0.425	76		
0.3	65		
0.212	51		
0.15	39		
0.063	26

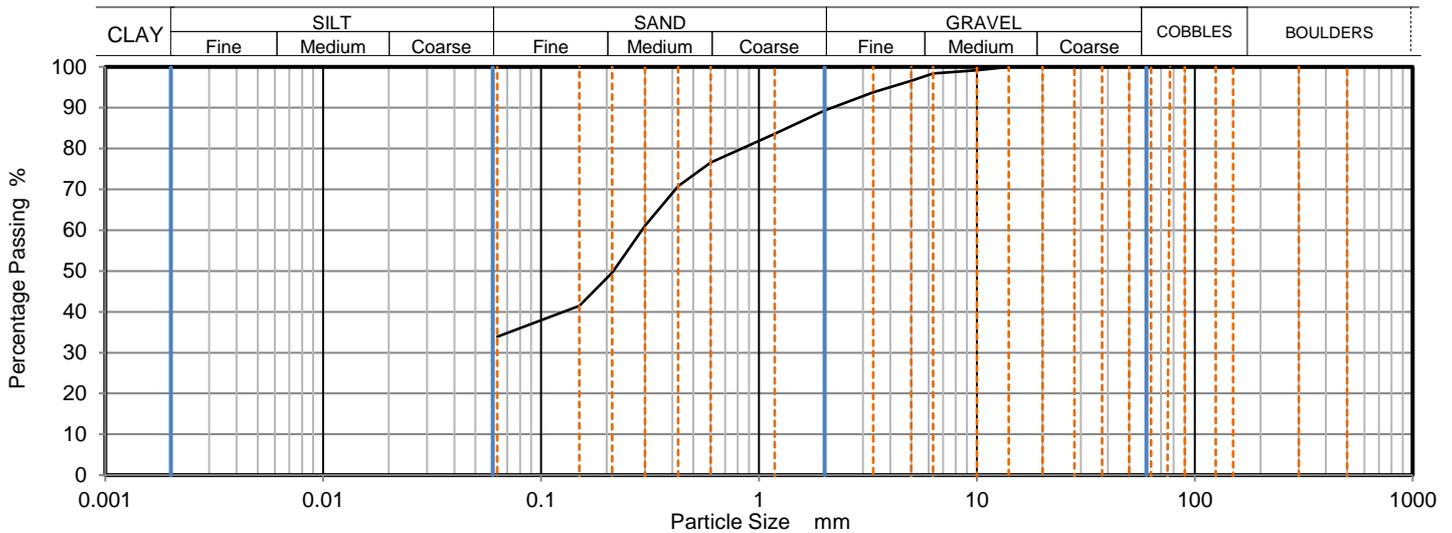
Depth Top [m]: 1.10
Depth Base [m]: Not Given
Sample Type: B

Sieving		Sedimentation	
Particle Size mm	% Passing	Particle Size mm	% Passing
500	100		
300	100		
150	100		
125	100		
90	100		
75	100		
63	100		
50	100		
37.5	100		
28	100		
20	100		
14	100		
10	99		
6.3	98		
5	97		
3.35	94		
2	89		
1.18	84		
0.6	77		
0.425	71		
0.3	61		
0.212	50		
0.15	42		
0.063	34

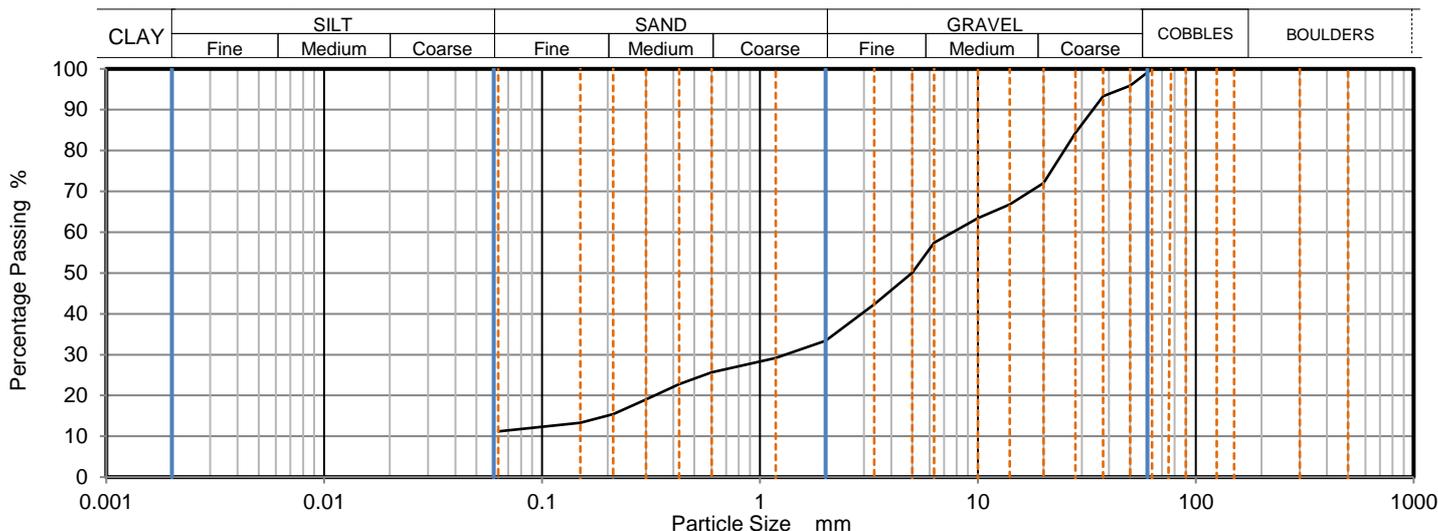
Depth Top [m]: 1.10
Depth Base [m]: Not Given
Sample Type: B

Sieving		Sedimentation	
Particle Size mm	% Passing	Particle Size mm	% Passing
500	100		
300	100		
150	100		
125	100		
90	100		
75	100		
63	100		
50	96		
37.5	93		
28	84		
20	72		
14	67		
10	63		
6.3	57		
5	50		
3.35	42		
2	33		
1.18	29		
0.6	26		
0.425	23		
0.3	19		
0.212	15		
0.15	13		
0.063	11

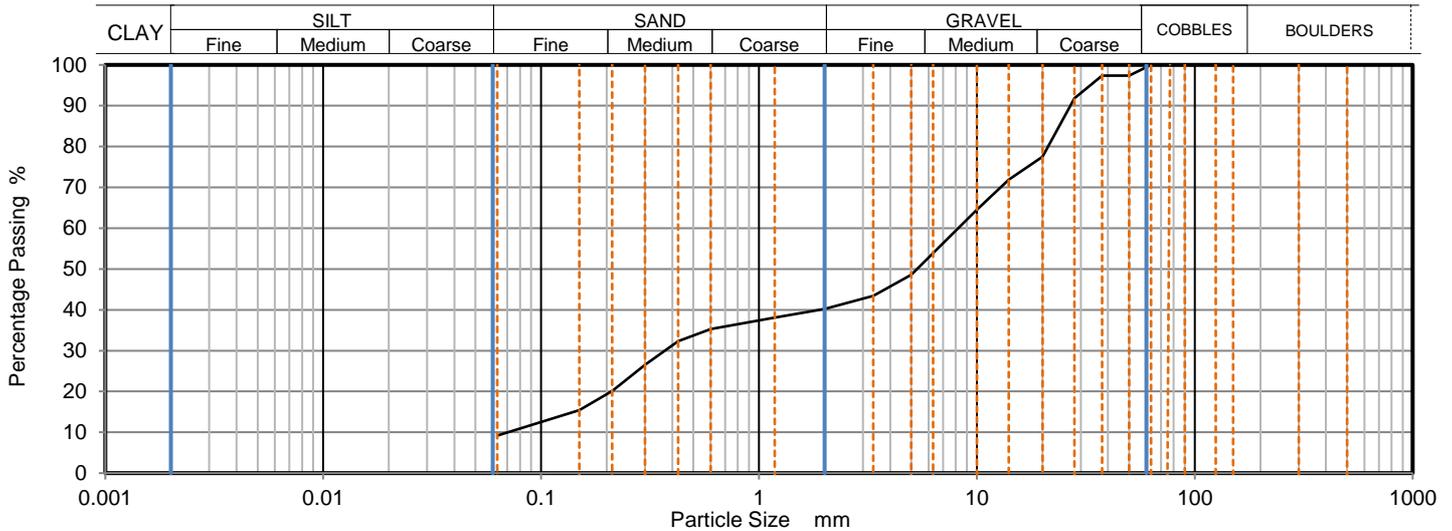
Depth Top [m]: 0.90
Depth Base [m]: Not Given
Sample Type: B

Sieving		Sedimentation	
Particle Size mm	% Passing	Particle Size mm	% Passing
500	100		
300	100		
150	100		
125	100		
90	100		
75	100		
63	100		
50	97		
37.5	97		
28	92		
20	78		
14	72		
10	65		
6.3	54		
5	49		
3.35	43		
2	40		
1.18	38		
0.6	35		
0.425	32		
0.3	27		
0.212	20		
0.15	15		
0.063	9
